Site Code: MNO12	Location: C	Grid Sq: 150/210	Context Type: MASONRY	Context Number: 3582
1. Materials	1. Bricks (red)			
2. Size of materials (brick: BTL in mm)	2. 230mm x 120mm x 650mm			
3. Finish of stones	3. N/A			
4. Coursing / bond	4. Single course surviving, headers			
5. Form	5. WALL			
6. Direction of face(s)				
7. Surface treatment	6. N/S			
8. Bonding material (if brick: record height of 4 courses & 4 bed joints in m)	7. None None seen as the surviving course is at or just below floor level, some mortar surviving on N face but could be associated with flooring?			
9. Dimensions of masonry as found	8. light grey lime mortar			
10. Other comments	9. 1m E-W x 0.25m N-S x 0.06m high			Max Level: 10.80m OD
				Min Level: 10.68m OD

Context Number:
3582

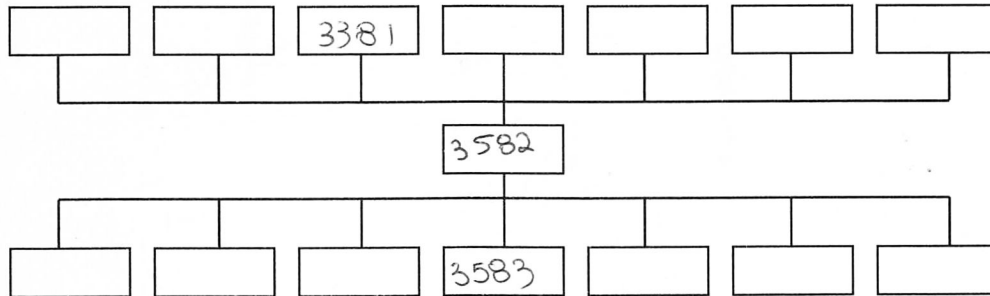
Stratigraphic Relationships:

Abuts:	Abutted by:
Cut by: 3381

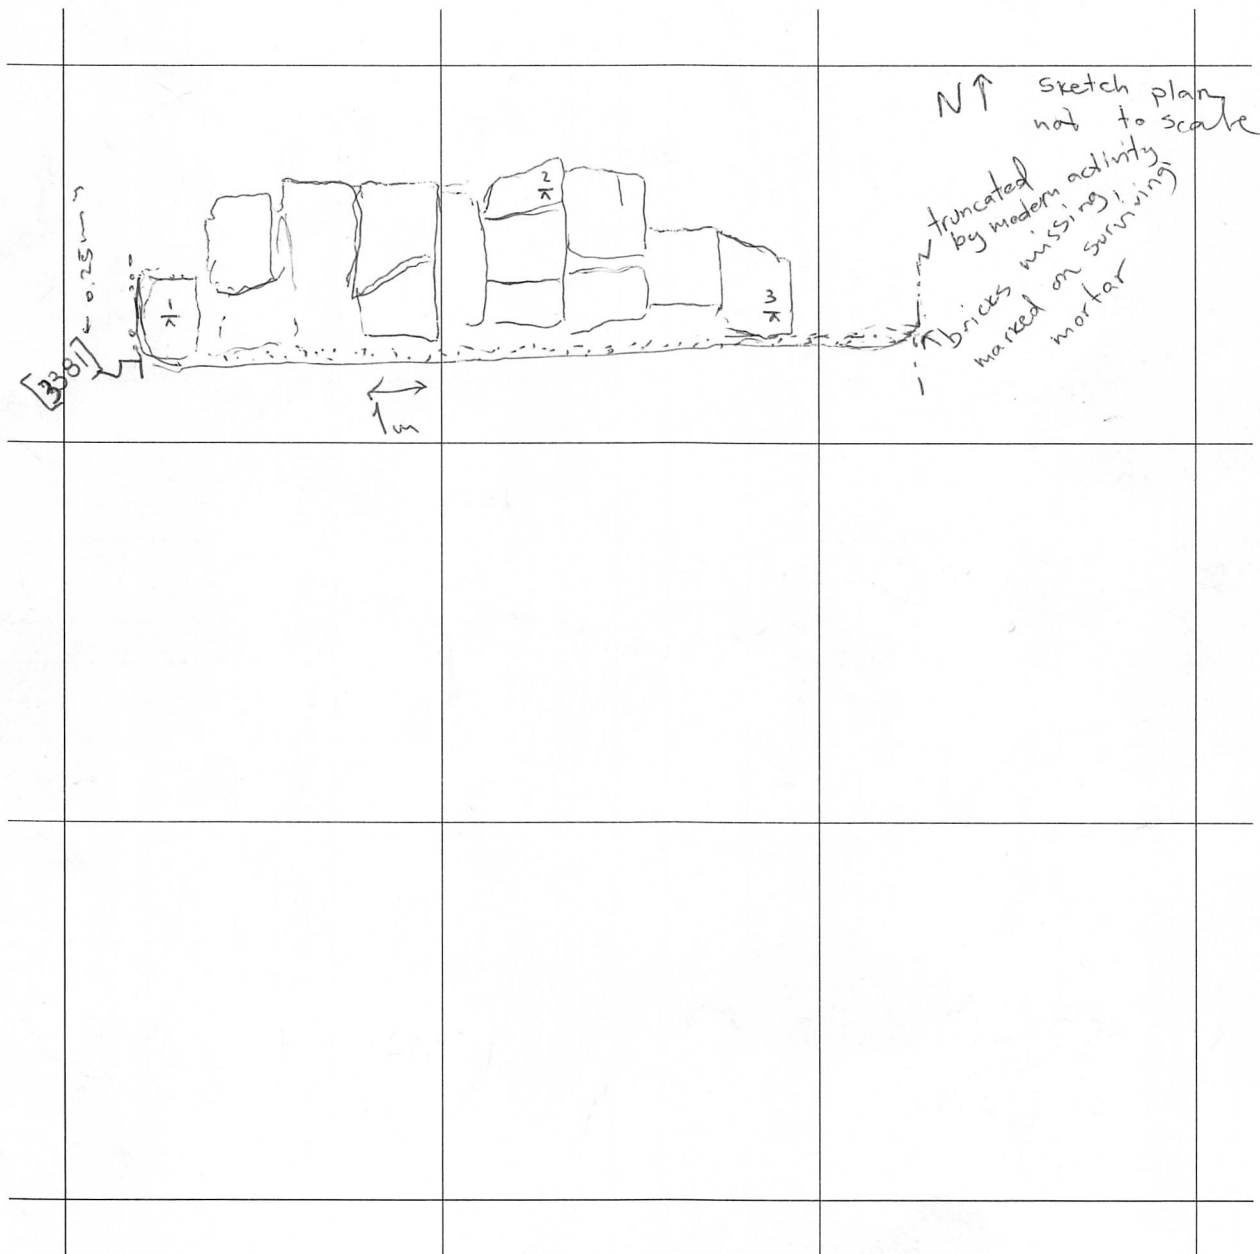
Interpretation:	<u>internal</u>	external
Internal / partition wall foundation only partly surviving - single course at / below floor level		
Context same as:

No.	F/S	R/L (m OD)	No.	F/S	R/L (m OD)	No.	F/S	R/L (m OD)	No.	F/S	R/L (m OD)
1	1.57	10.68									
2	1.47	10.78									
3	1.45	10.80
