Site Code: MNO12	Location: AREA D	Grid Sq: 140/230 140/225	Context Type: Cut	Context Number: 3880
Deposit	1. Rectangular/Linear			Cut
1. Compaction	2. Sharp			1. Shape in Plan
2. Colour	3. NS-1.4m EW-0.4m			2. Corners
3. Composition	Depth-0.12m			3. Dimensions
4. Inclusions	4. Sharp drop			4. Break of slope - Top
5. Interface	5. Vertical/slightly sloped			5. Sides
6. Dimensions	6. Right angled			6. Break of slope - Base
7. Other Comments	7 Flat			7. Base
8. Method/Conditions	Text 8. North/South			8. Orientation
9. N/A				9. Inclination
10. Truncated by the South by E+I concrete pile				10. Truncation
11. Runs into the L.O.F to the North				11. Other comments
				Max Level: 10.77 m OD
				Min Level: 10.61 m OD

Interpretation:	<input checked="" type="checkbox"/> Internal	<input type="checkbox"/> External	<input type="checkbox"/> Structural
Construction cut for brick wall [3840] running on a North South alignment at the North Western corner of area D			
Context same as:

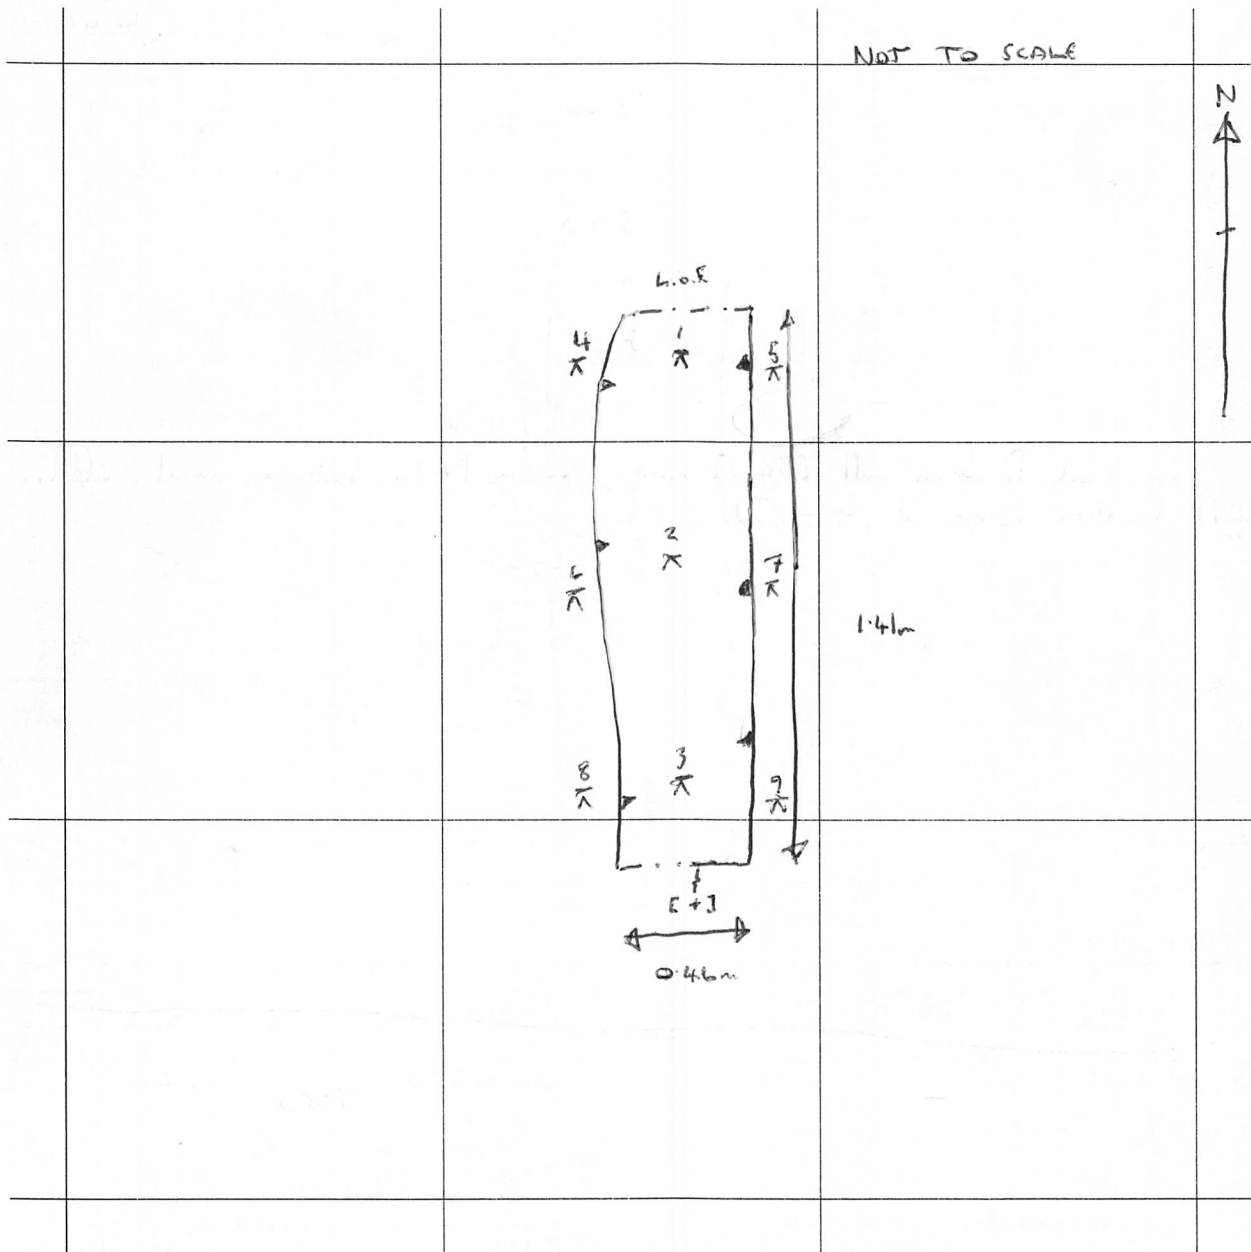
Context Number:
3880

No.	F/S	R/L (m OD)	No.	F/S	R/L (m OD)	No.	F/S	R/L (m OD)	No.	F/S	R/L (m OD)
1	1.54	10.62	6	1.48	10.68						
2	1.55	10.61	7	1.44	10.72						
3	1.53	10.63	8	1.39	10.77						
4	1.43	10.73	9	1.45	10.71						
5	1.45	10.71
