Site Code: MNO12	Location: D	Grid Sq: 145-50 / 220	Context Type: MASONRY	Context Number: 3963
1. Materials	1. Yellow-red bricks (same as 3926)			
2. Size of materials (brick: BTL in mm)	2. 105 x 64 x 225 mm			
3. Finish of stones	3. Bricks			
4. Coursing / bond	4. Strata on edge			
5. Form	5. Roof of drain			
6. Direction of face(s)	6. Up + down			
7. Surface treatment	7. None			
8. Bonding material (if brick: record height of 4 courses & 4 bed joints in m)	8. Same as mortar used on other plots			
9. Dimensions of masonry as found	9. 0.9m x 0.34m x 0.1m thick			
10. Other comments				Max Level: 10.49 m OD
				Min Level: m OD

Context Number:
3963

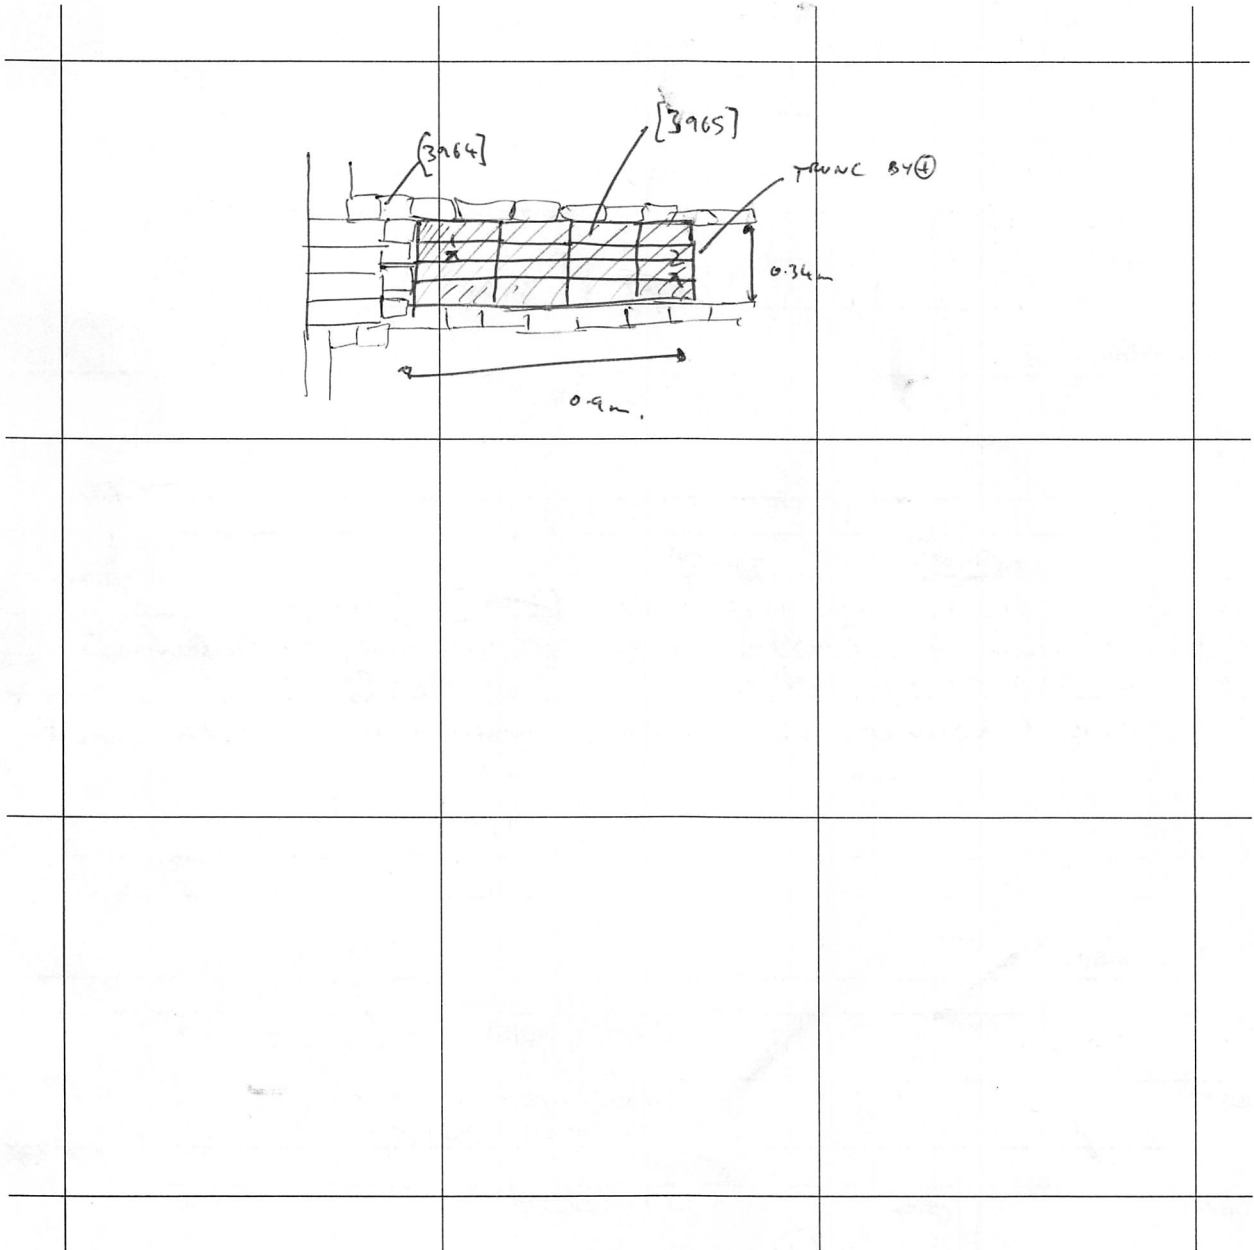
Interpretation:	<u>internal</u>	external
Roof of E-W drain running into drain [3964] - [3964]		
Roof of yellow-red bricks on edge as seen from arch, possible rubble?		
Different mortar + bricks compared to sides + base [3964]		
This drain is diversion of previous drain which lay to south		
Context same as:
