Site Code: <b>MNO12</b>	Location: <b>G</b>	Grid Sq: <b>150/230-235</b>	Context Type: <b>MASONRY</b>	Context Number: <b>4537</b>
1. Materials	1. BRICK (MID GEORGIAN RBD. HARD, UNEVENED)			
2. Size of materials (brick: BTL in mm)	2. 100mm x 60mm x 220mm			
3. Finish of stones	3. <del>PLAIN</del> MOULDDED BRICKS			
4. Coursing / bond	4. TOO TRUNCATED TO ESTABLISH			
5. Form	5. WALL CORNER			
6. Direction of face(s)	6. N/A			
7. Surface treatment	7. [4536]			
8. Bonding material (if brick: record height of 4 courses & 4 bed joints in m)	8. MORTAR (HARD MID GREYISH YELLOW CHALK INCLUSIONS (2-4mm), OCCA. CHARCOAL FLAKES. MORTAR OF 4:0.28m			
9. Dimensions of masonry as found	9. 0.48m N-S, 0.57m E-W, 0.45m HEIGHT			
10. Other comments	1. MATS. COM. - CHALK LUMPS		Max Level: 11.24 m OD	
100-200mm BUILT INTO WALL			Min Level: 10.94 m OD

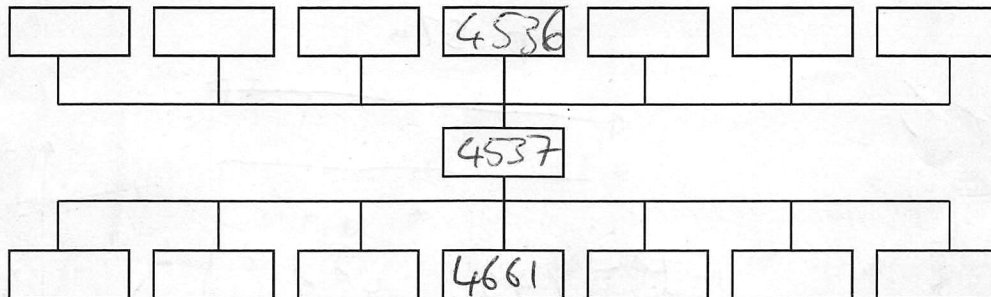
Stratigraphic Relationships:

Abuts:	Abutted by: 4656, 4536, 4546
Cut by: 4658

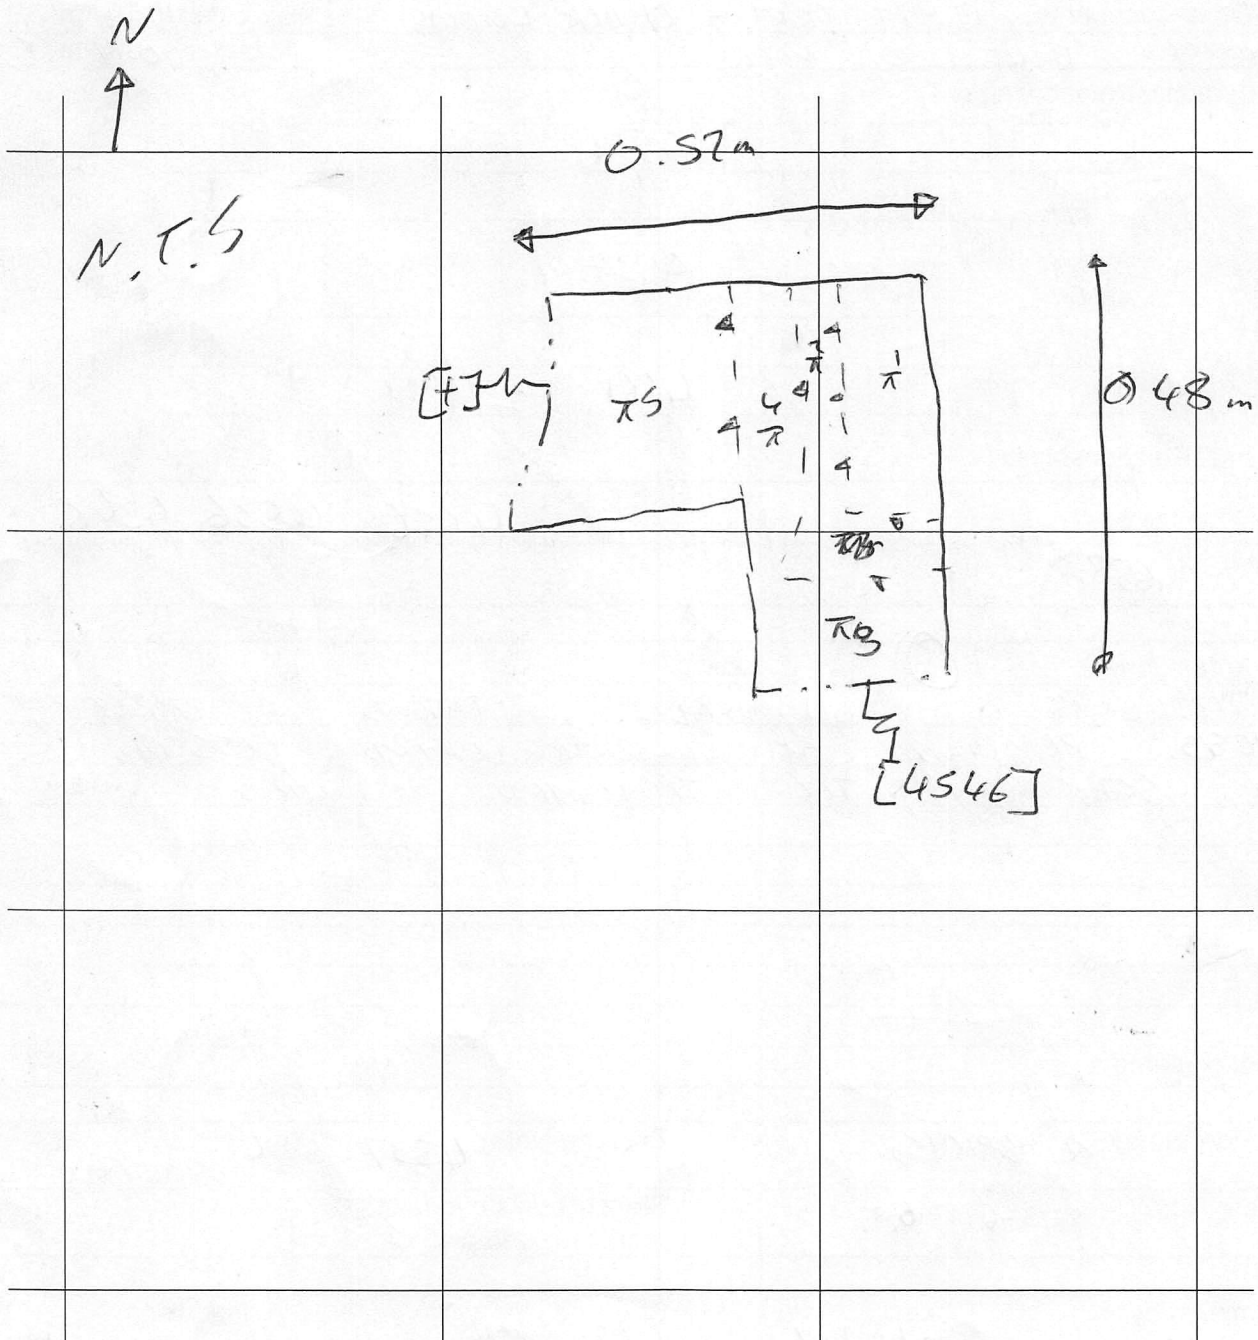
Interpretation:	<input checked="" type="checkbox"/> internal	<input type="checkbox"/> external
INTERNAL PRE-GEORGIAN WALL. FORMS A CORNER, POSS. REMAINS OF A TRUNCATED CROSS PIT OR SOAKAWAY, TOO TRUNCATED TO TELL		
Context same as:
