Site Code: <b>MNO12</b>	Location: <b>G.</b>	Grid Sq: <b>15C / 235</b>	Context Type: <b>MASONRY</b>	Context Number: <b>4634</b>
1. Materials	① MID ORANGE RED, HAND MADE, UNFLOORED BRICK.			
2. Size of materials (brick: BTL in mm)	② 100 x 65 x 220			
3. Finish of stones	③ -			
4. Coursing / bond	④ HEADERS ON BED			
5. Form	⑤ BRICK FLOOR			
6. Direction of face(s)	⑥ VERTICAL, UP			
7. Surface treatment	⑦ NONE			
8. Bonding material (if brick: record height of 4 courses & 4 bed joints in m)	⑧ MID BROWNISH YELLOW SANDY LIME MORTAR. OCC; LIME LUMPS ≤ 20mm CHARCOAL FLECKS ≤ 10mm			
9. Dimensions of masonry as found	⑨ N-S 0.25m EW 0.48m DO 0.08m			
10. Other comments				Max Level: 12.10 m OD Min Level: 12.02 m OD

Interpretation:	internal	external
<b>BRICK FLOOR, LIKELY EXTERNAL. TO REBUILD <sup>1</sup> 4633</b>		
<b>OVERLAYS MORTAR BEDDING TO NORTH.</b>		
<b>TRUNCATED S BY (+)</b>		
Context same as:

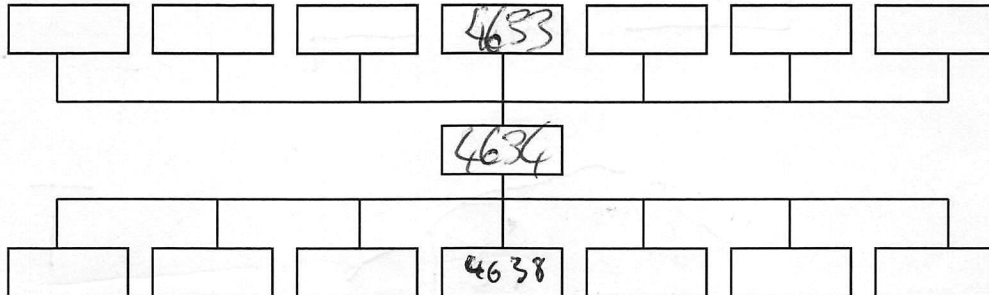
Stratigraphic Relationships:

Abuts: <b>463</b>	Abutted by: <b>4633</b>
Cut by: <b>(+)</b>

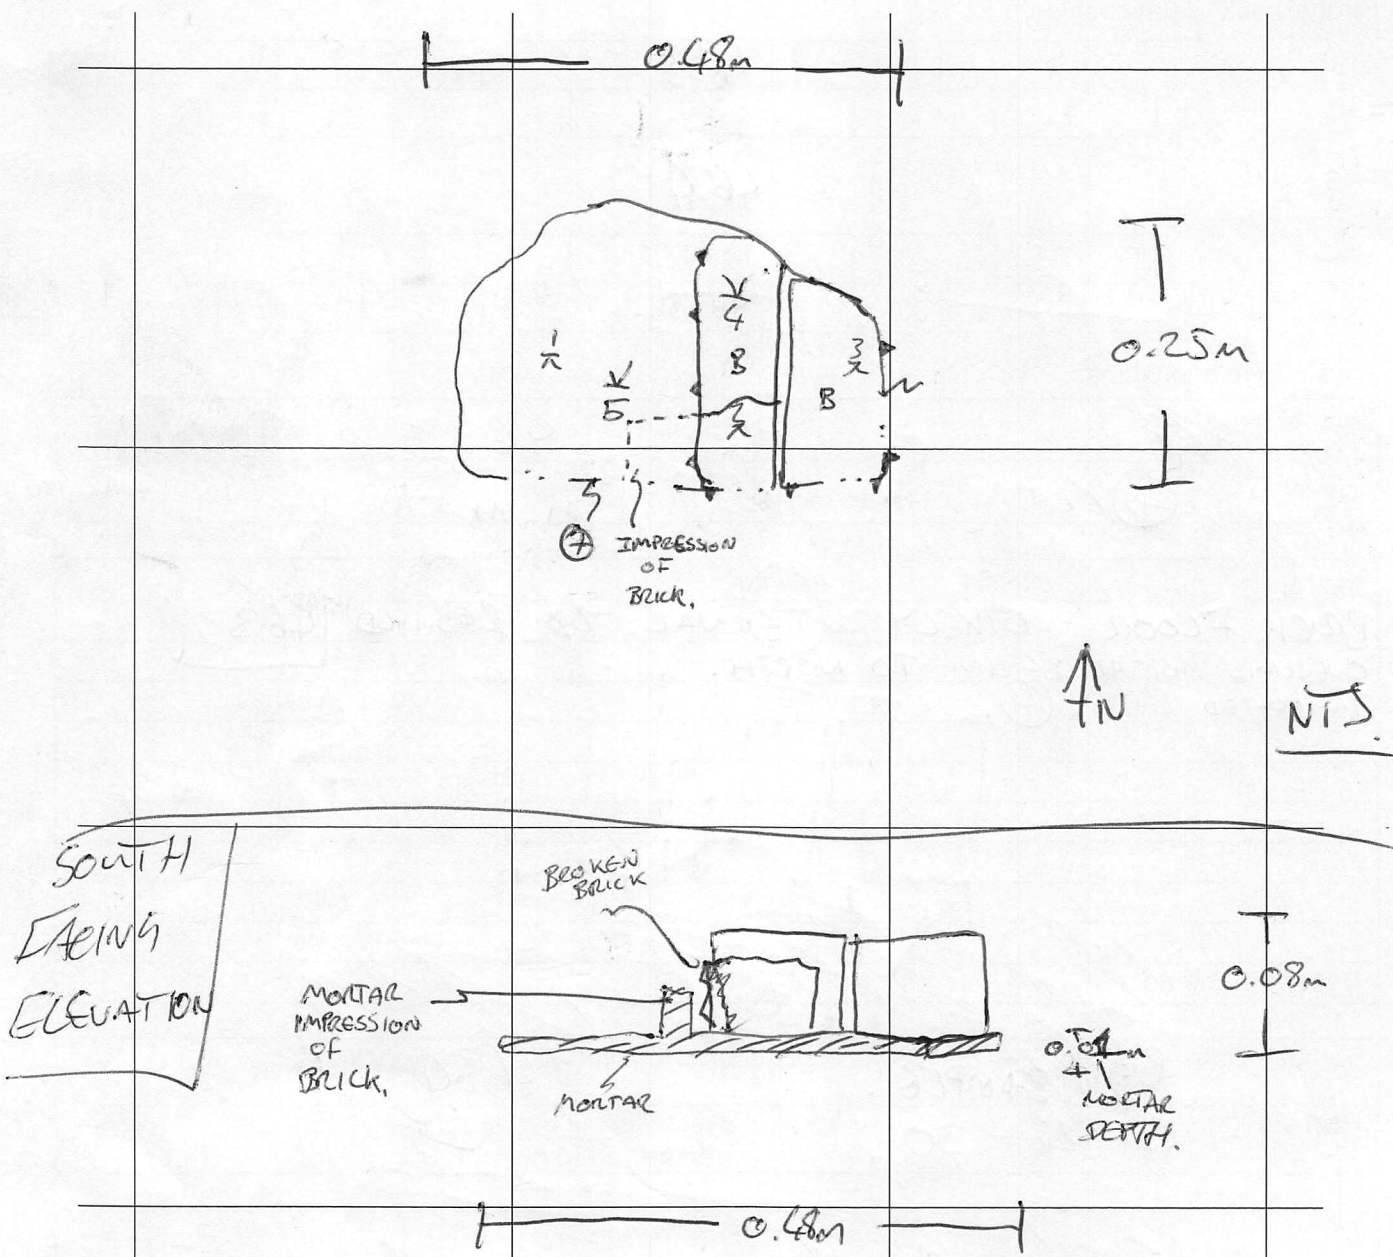
4634.

No.	F/S	R/L (m OD)	No.	F/S	R/L (m OD)	No.	F/S	R/L (m OD)	No.	F/S	R/L (m OD)
1		12.04									
2		12.09									
3		12.10									
4		12.02									
5		12.02
