Site Code: MNO12	Gr. Sq. / TP / Tr: SQUA	Context Type: MASONRY	Context Number: 212
1. Materials	1.50% SFT (RED) HANDMADE UNFROSTED BRICKS, 20% MEDIUM		
2. Size of materials (brick: BTL in mm)	HAND RED UNFROSTED BRICKS WITH SOME SPANISH /		
3. Finish of stones	CLAY IN CONC 2. BTL 107x58x225mm		
4. Coursing / bond	3. BATS + HALF BATS		
5. Form	4. ROUGH COURSED		
6. Direction of face(s)	5. FOUNDATION + SUPERSTRUCTURE E-W ALIGNMENT		
7. Bonding material (if brick: record height of 4 courses & 4 bed joints in m)	6. NORTH		
8. Dimensions of masonry as found	7. SFT MUD GLENN ASHY LIME MORTAR		
9. Other comments	4 COURSE = 0.31m		
	8. > 2.25m x 70.7m x 70.28m THICK N-S		
	9. EXTENDS BEYOND EXISTING LOC.		
	MORTAR LEVEL 10.16m		
	MORTAR LEVEL 9.46m

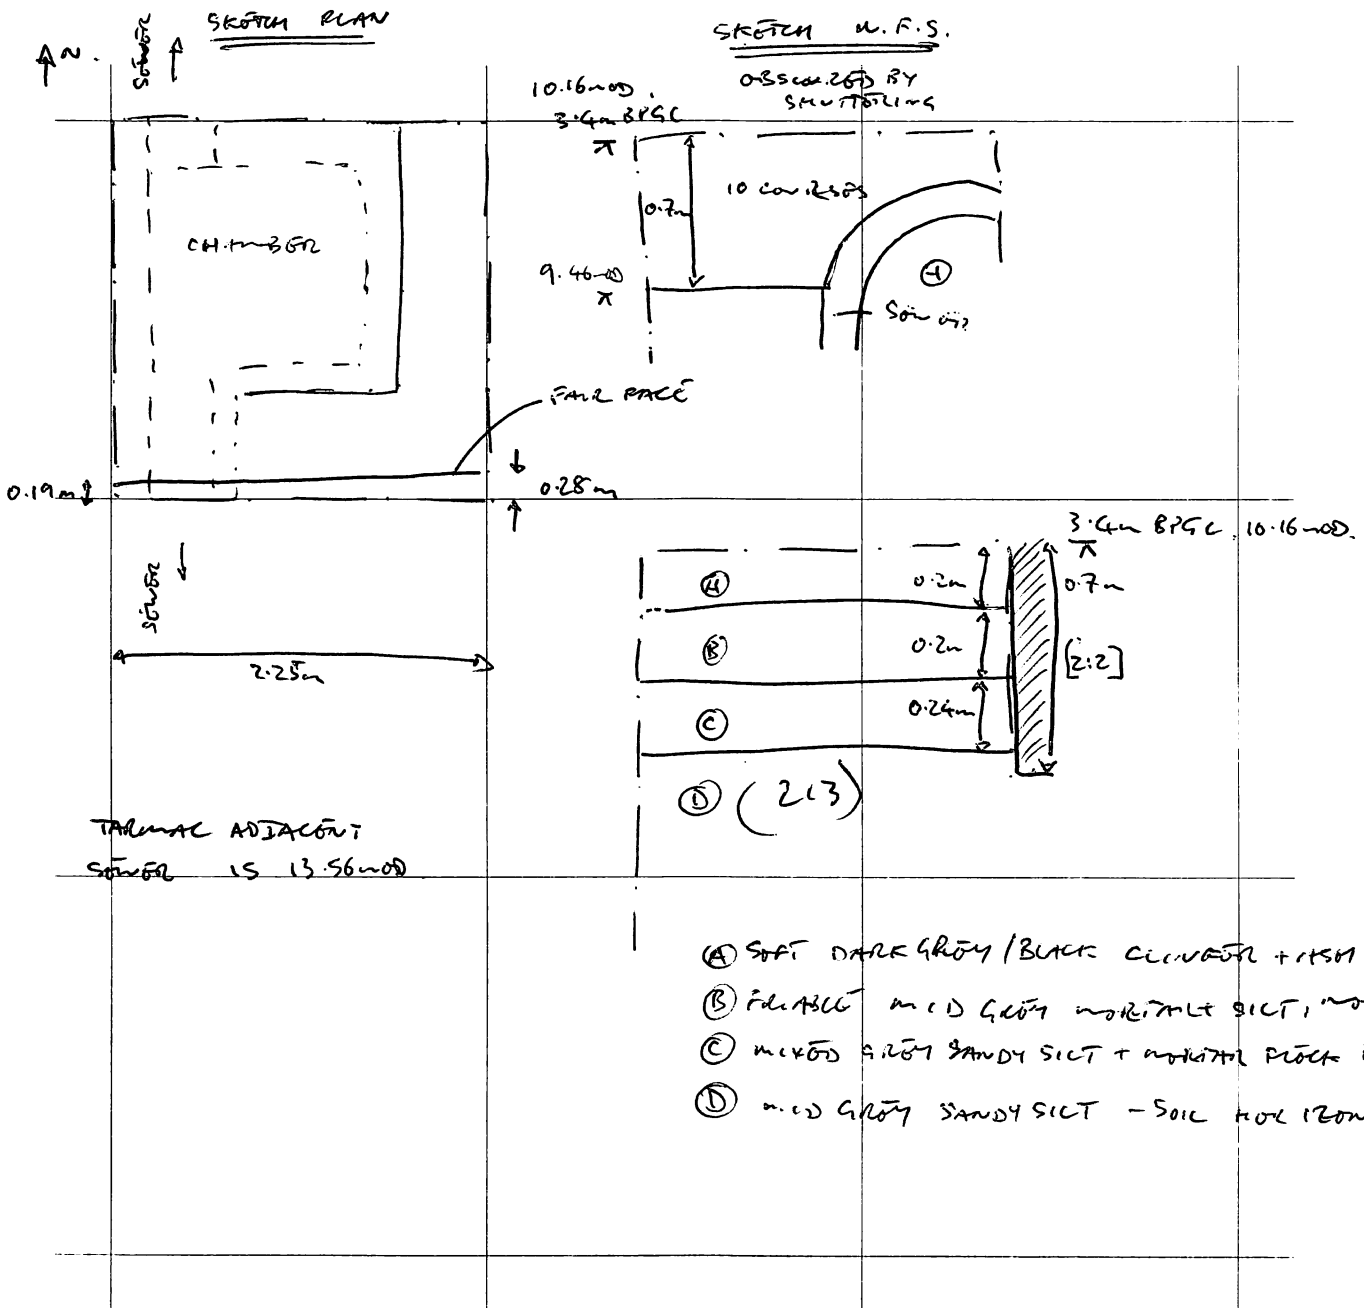
Interpretation:	internal	<u>external</u>
17th c. brick - m observed at S. side of small digment shaft.		
FACE FACE TO NORTH. W/BRICK CONDITIONS FROM UNCERTAIN		
IF WHOLE CONSTRUCTION COURSE (SEE SKETCH).		
BRICK RUBBLE HAD BEEN OBSERVED ON THIS ALIGNMENT		
AT HIGHER LEVEL IN SHAFT.		
Context same as:
