Site Code: MNO12	Gr. Sq. / TP / Tr: A	Context Type: MASONRY	Context Number: 259
1. Materials			
2. Size of materials (brick: BTL in mm)	1. PURPLISH RED HARD V. SLIGHTLY ERRODED BRICKS, YELLOW MOUNDING SAND		
3. Finish of stones	2. 100 X 62 X 225.		
4. Coursing / bond	3. BRICKS. SOME 1/2 BATS.		
5. Form	4. ENGLISH		
6. Direction of face(s)	5. WALL.		
7. Bonding material (if brick: record height of 4 courses & 4 bed joints in m)	6. MORTAR		
	7. LIGHT SANDY CRUMBY SANDY LIME MORTAR, SOME LIME PEPPERS. C COURSE: 0.35m.		
8. Dimensions of masonry as found	8. 0.72m wide.		
9. Other comments

Context Number:
259.

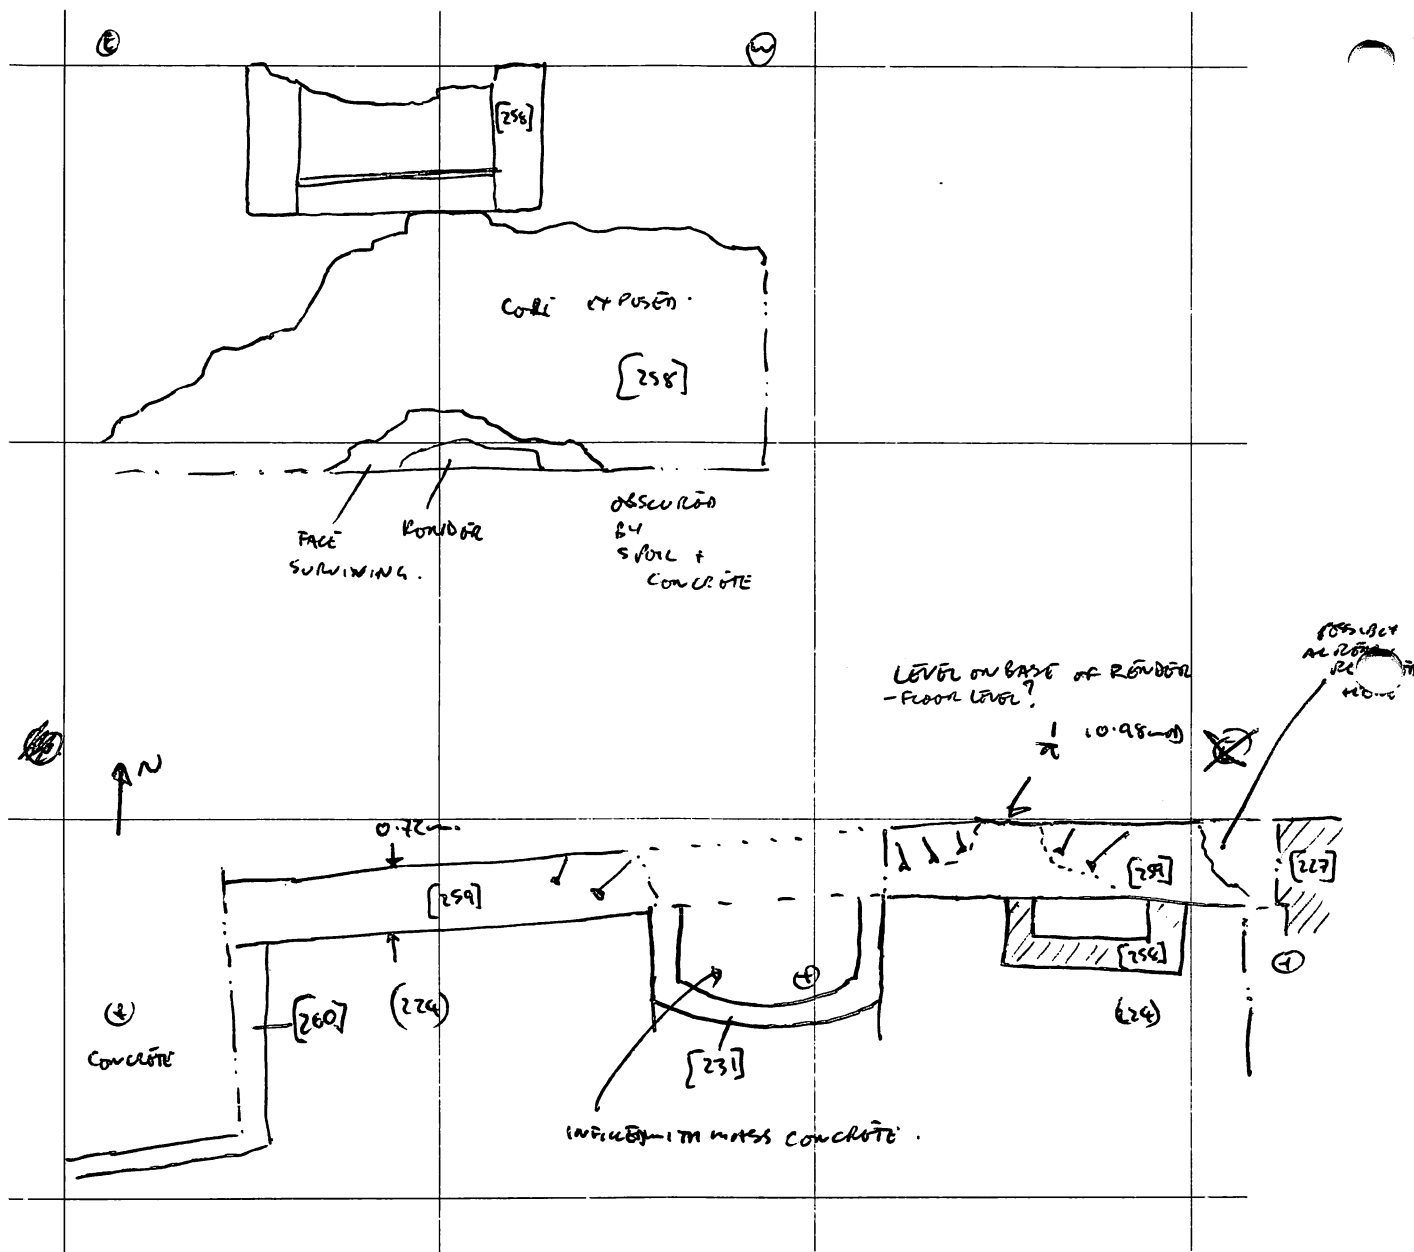
SKETCH PLAN

Interpretation:	internal	external
E-W WALL. V. FAINT FLOORS. ? WALL STREET /		
HAMMERT STREET ORIGINAL FRONTAGE?		
TRUNC BY CONCRETE AT E+W. N. FACE DAMAGED DURING BLOWING.		
Context same as: wall [230] TO EAST
