Site Code: <b>MNO12</b>	Gr. Sq. / TP / Tr: <b>A</b>	Context Type: <b>MASONRY</b>	Context Number: <b>273</b>
1. Materials	1 <b>ORANGE-RED HANDMADE BRICKS</b>		
2. Size of materials (brick: BTL in mm)	2. <b>? x 60 x 270 mm</b>		
3. Finish of stones	3. <b>BATS + 1/2 BATS</b>		
4. Coursing / bond	4. <b>ROUGH ENGLISH?</b>		
5. Form	5. <b>WALL</b>		
6. Direction of face(s)	6. <b>WEST</b>		
7. Bonding material (if brick: record height of 4 courses & 4 bed joints in m)	7 <b>SOFT LIGHT GREY ASHY LINE MATERIAL, OVER CHALK FLOORS</b> 8 <b>COURSE = 0.3m</b>		
8. Dimensions of masonry as found	8. <b>0.66 N-S x 0.50m HIGH UNKNOWN WIDTH</b>		
9. Other comments	9. <b>TRUNC TO S + ABOVE</b>		
			MAX 12.56 m <sup>2</sup>
			MW 11.98 m <sup>2</sup>

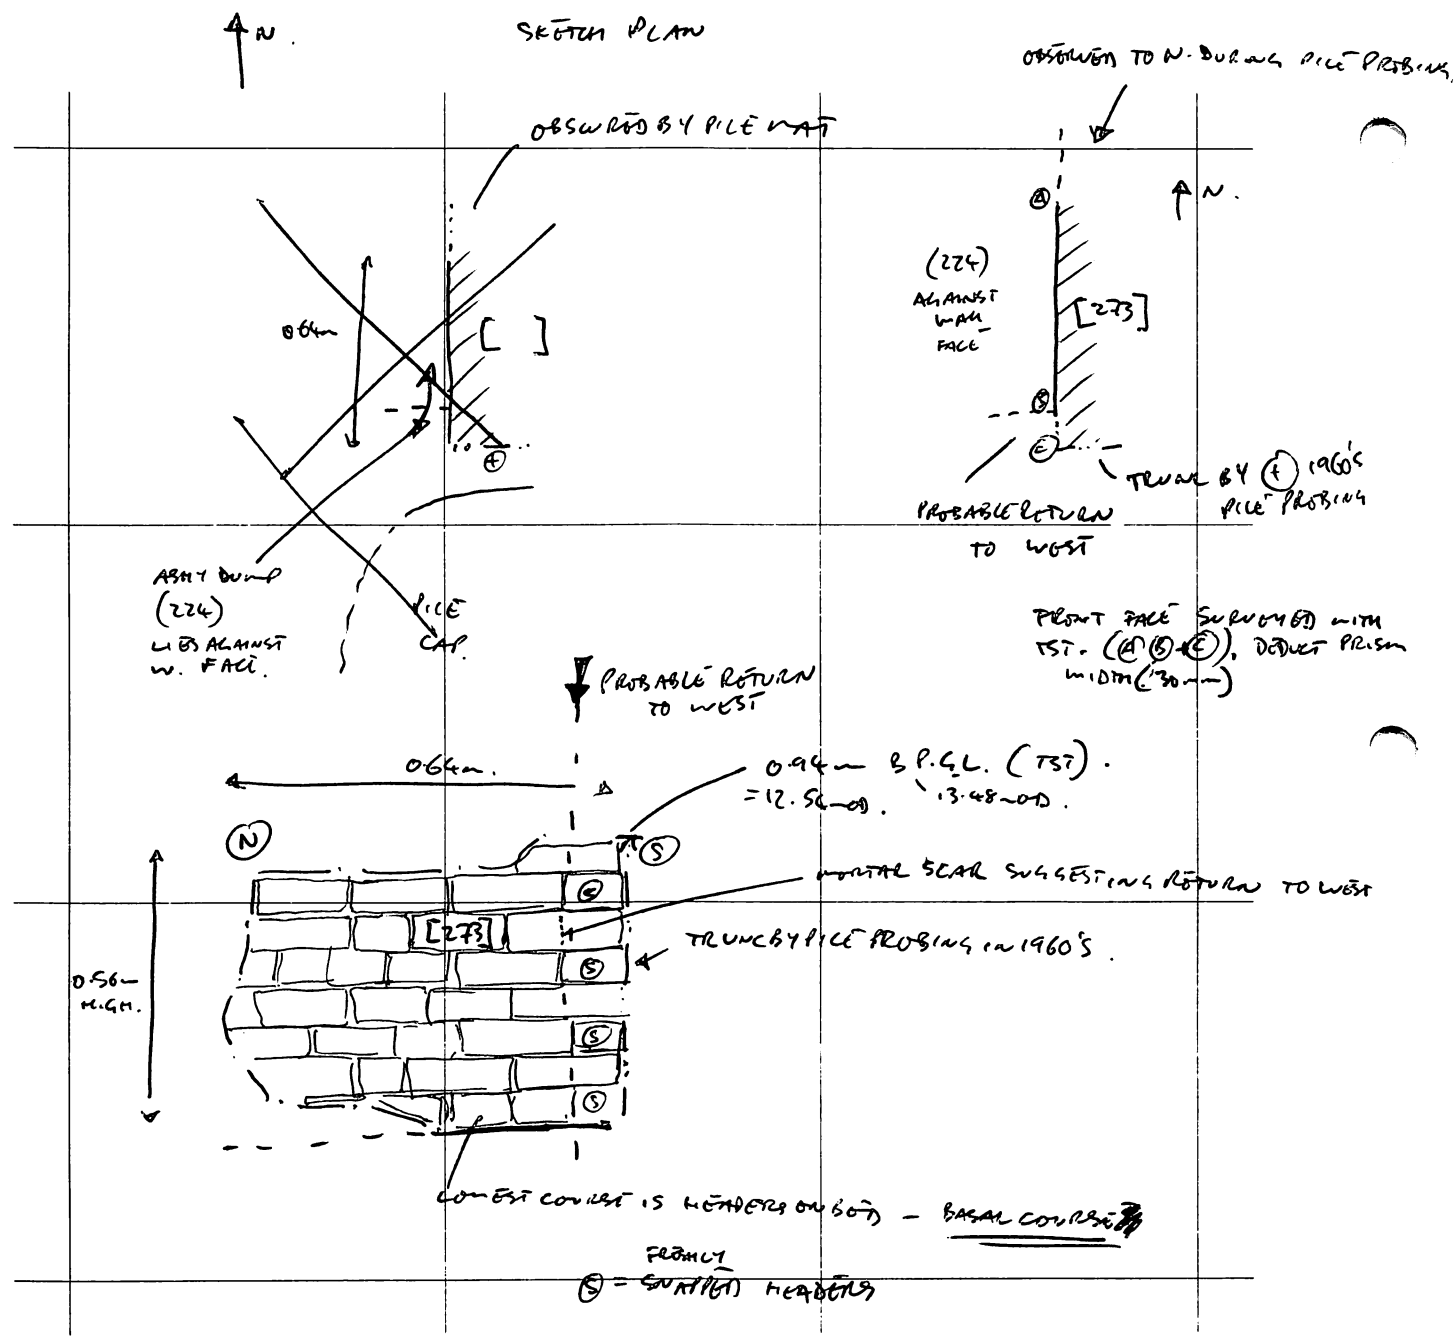
Sketch Plan & Notes

Interpretation:	<u>internal</u>	external
WALL, OBSERVED IN FILE PROSING, RECORDED UNDER TELECOM CHAMBER. TRUNC TO S. BY (E) WALL CAP.		
FAIR FACE TO <sup>WEST</sup> SOUTH. LATE? 17c c?? STREET FRONTAGE WALL?		
EASER COURSE OF HEADERS ON END.		
MANY ROUSED BRICKS.		
<u>POSSIBLY RETURNED TO WEST AT SOUTHERN END (SMALLER HEADERS).</u>		
Context same as:
