Site Code: MNO12	Gr. Sq. / TP / Tr: AREA A.	Context Type: MASONRY	Context Number: 1030
1. Materials	1. PURPLISH RED BRICK.		
2. Size of materials (brick: BTL in mm)	2. 95 x 55 x 240.		
3. Finish of stones	3. /		
4. Coursing / bond	4. SINGLE UNKNOWN - SEEN IN SECTION - ONLY SMALL PORTION OF WALL		
5. Form	5. POSSIBLE LIGHTWELL - ONE EXPOSED FACE FACING NORTH. - TRENCH		
6. Direction of face(s)	BUILT TO SOFA?		
7. Bonding material (if brick: record height of 4 courses & 4 bed joints in m)	6. NORTH.		
8. Dimensions of masonry as found	7. LIGHT GREY WHITE CHALKY MORTAR c 300mm FOR 4 COURSES -		
	12 COURSES TO BASE.		
9. Other comments	8. 930mm DEPTH x 200mm (BRICK + MORTAR) MAX, 100mm MIN N/S x		
	140mm E/W INTO EASTERN L.O.E. SECTION.		
	9. VERY SLIGHTLY OFF VERTICAL $\frac{1}{2}$ 95°? PERHAPS DUE TO USE AS LIGHTWELL?		
	map 13.27 -03 site 12.34 -03

Context Number:
1030

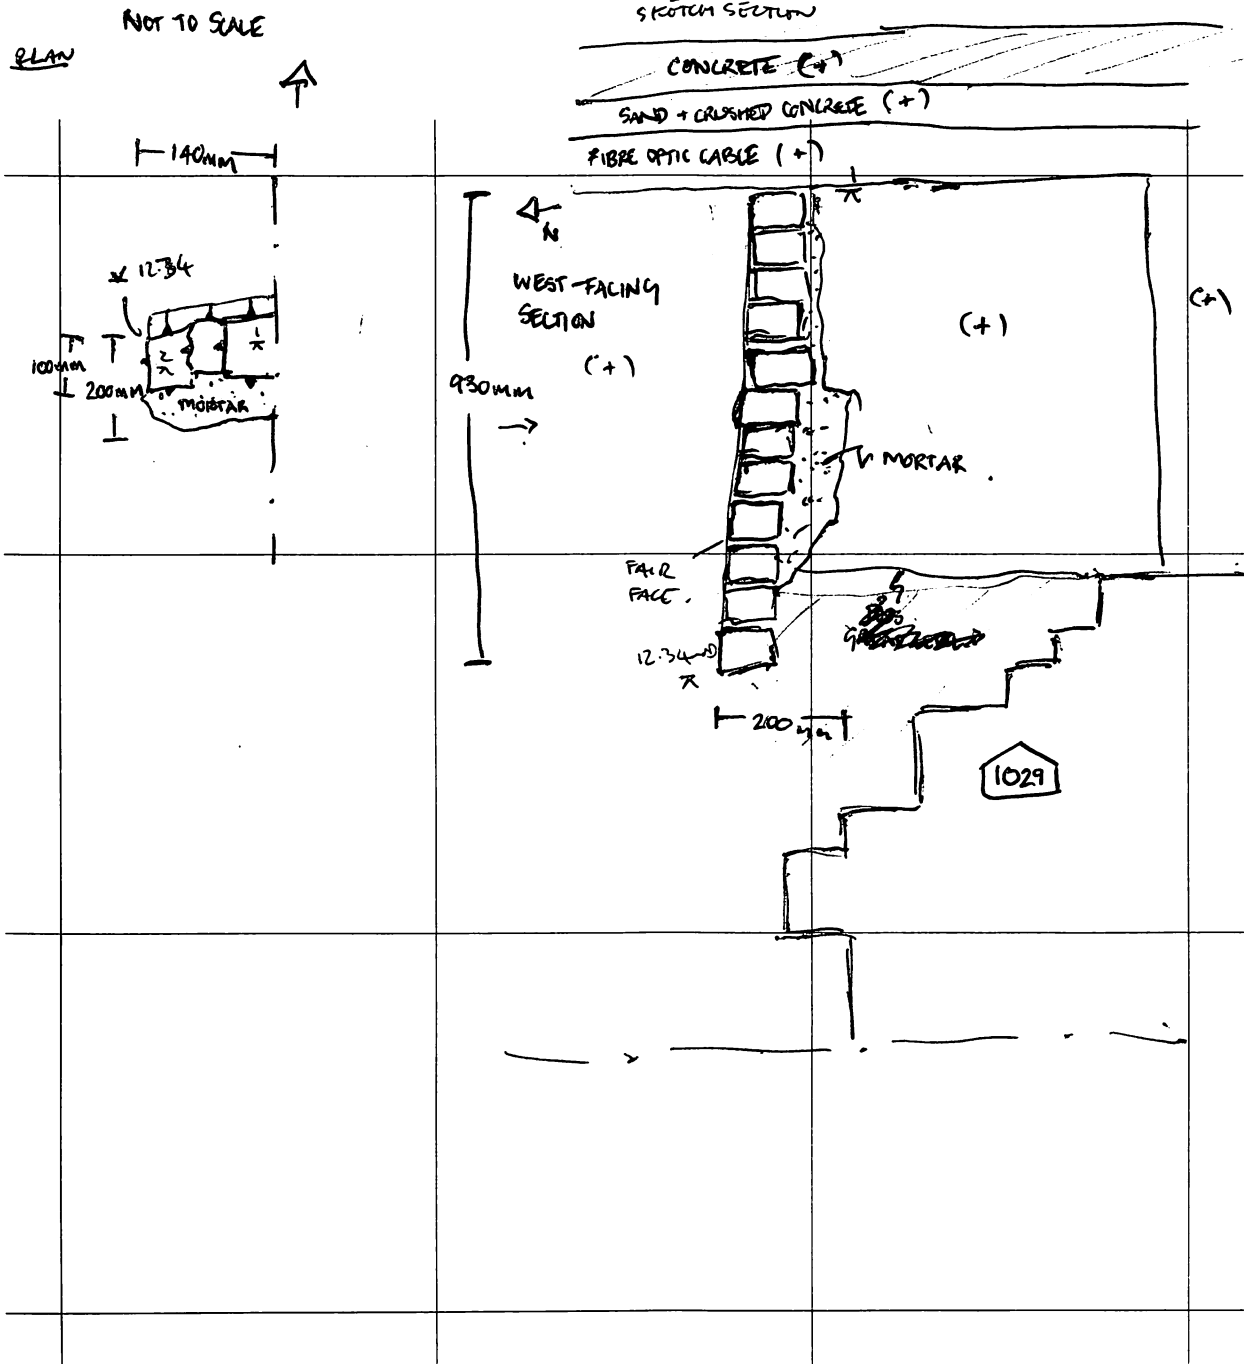
Interpretation:	internal	external
POSSIBLE E/W RUNNING LIGHTWELL, POSS. TRUNCATED AT TOP BY CONSTRUCTION OF MODERN FOOTPATH, AND BY CONSTRUCTION OF E/W VICTORIAN LIGHTWELLS - SINGLE WIDTH WALL SUGGESTS NOT LOAD BEARING - FOR LIGHT BETWEEN HALF BASEMENT AND STREET LEVEL ALONG PARALLEL SE? MINORIES		
Context same as:
