Site Code: MNO12	Location: A	Grid Sq: 140/245 145/245	Context Type: CUT	Context Number: 1187
Deposit 1. Compaction 2. Colour 3. Composition 4. Inclusions 5. Interface 6. Dimensions 7. Other Comments 8. Method/Conditions	① LINEAR ② N/A ③ 5.3 m x 0.3 - 1.1m x 1.2m ④ SHARP ⑤ NEAR VERTICAL / VERTICAL ⑥ HORIZONTAL ⑦ FLATISH ⑧ - E-W Text			Cut 1. Shape in Plan 2. Corners 3. Dimensions 4. Break of slope - Top 5. Sides 6. Break of slope - Base 7. Base 8. Orientation 9. Inclination 10. Truncation 11. Other comments
	⑨ UPRIGHT			
	⑩ POSSIBLY TRUNCATED BUT UNLIKELY			
	⑪ CURT TO REPOINT WALL AND PUT IN LIGHTWELL [1159]			
				Max Level: 9.85m OD
				Min Level: 10.35m OD

Context Number:
1187

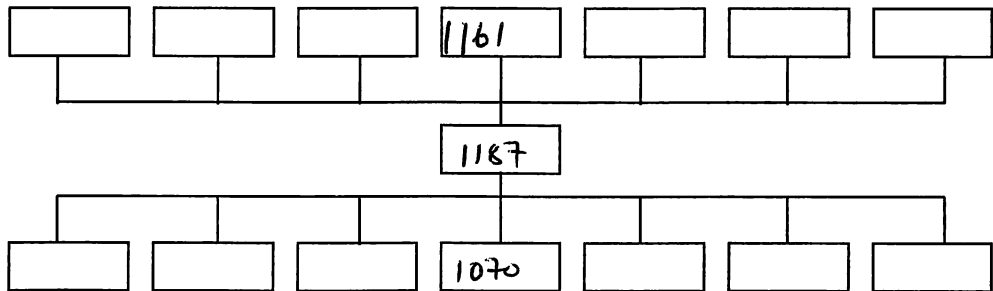
Interpretation:	Internal	External	Structural
LINEAR CUT ALONG OUTSIDE (S) OF WALL 1072 TO REPOINT MORTAR AND FOR CONSTRUCTION OF LIGHTWELL [1159]. FILLED WITH (19th CENTURY) DEBRIS (1161) PART OF (19th CENTURY) REWORKING OF BUILDINGS.			
Context same as:

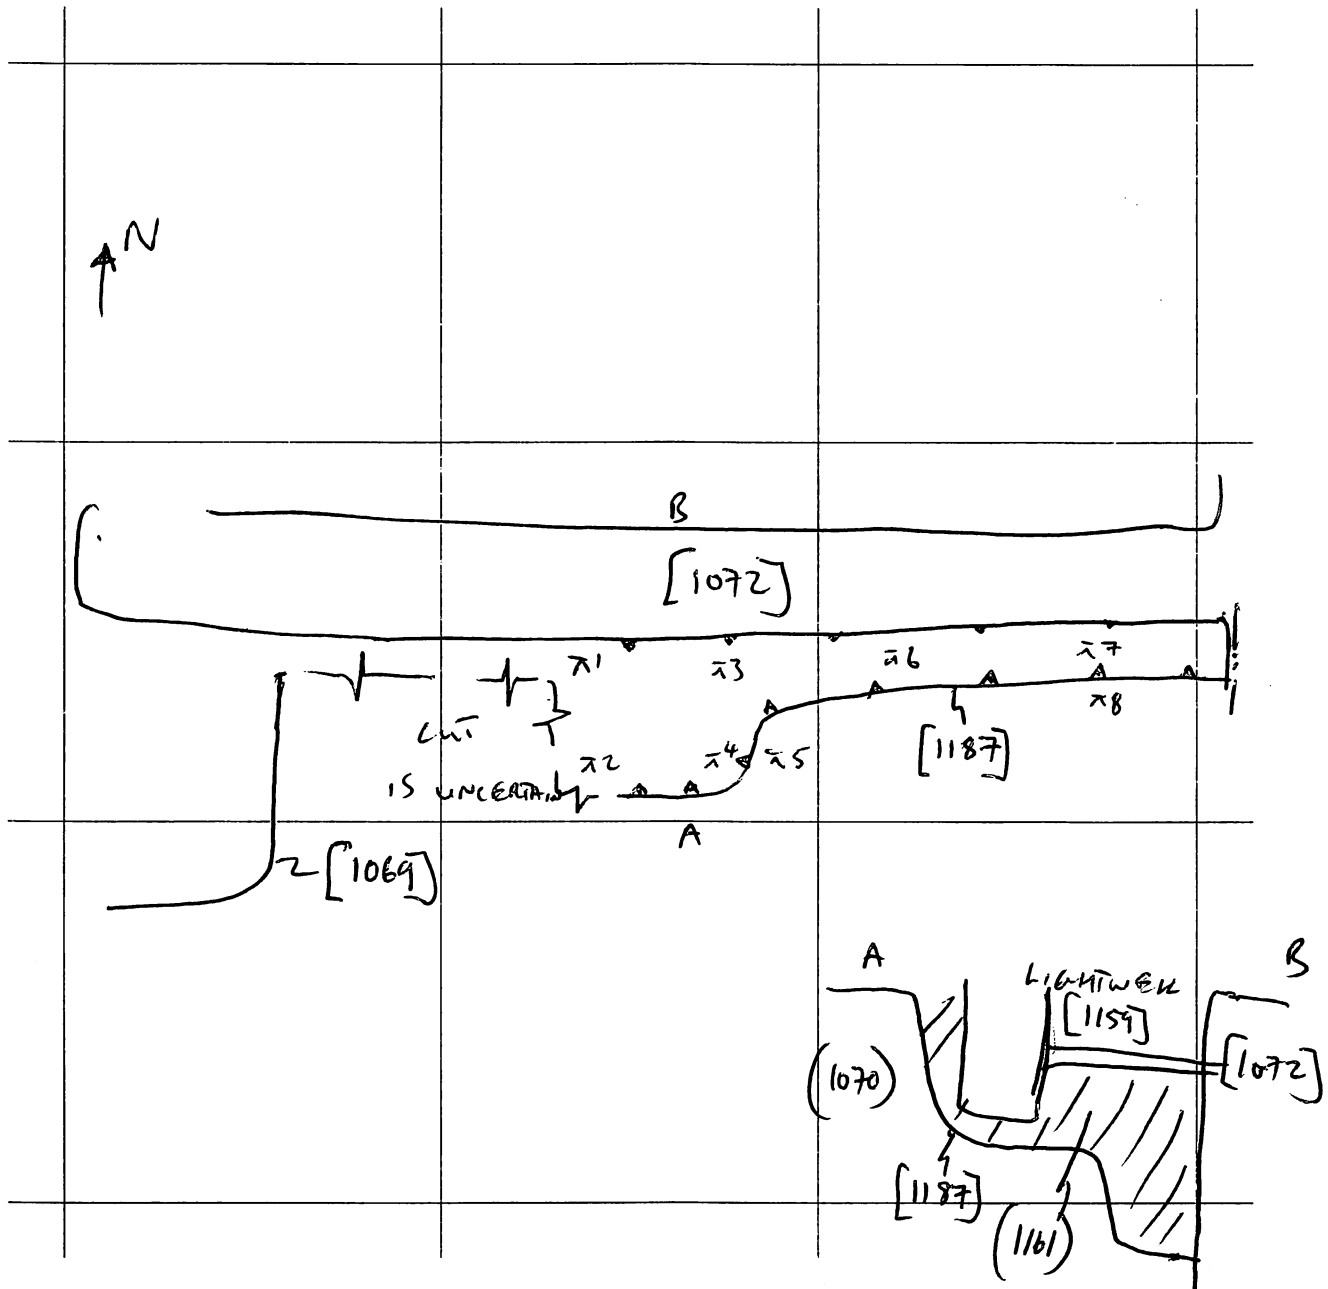
No.	F/S	R/L (m OD)	No.	F/S	R/L (m OD)	No.	F/S	R/L (m OD)	No.	F/S	R/L (m OD)
1		9.85	6		9.95m						
2		10.33	7		9.97						
3		9.90	8		11.13						
4		10.35									
5		11.16m
