| Site Code:<br><i>MNO17</i> | Gr. Sq. / TP / Tr:<br><i>A</i> | Context Type:<br><b>MASONRY</b> | Context Number:<br><i>206</i> |
| 5. Form | <i>5. BRICK CORNER WALL</i> | | |

| <i>CORNER WALL, N-S ALIGNED, FAIR FACE TO N, E + W.</i> | | |

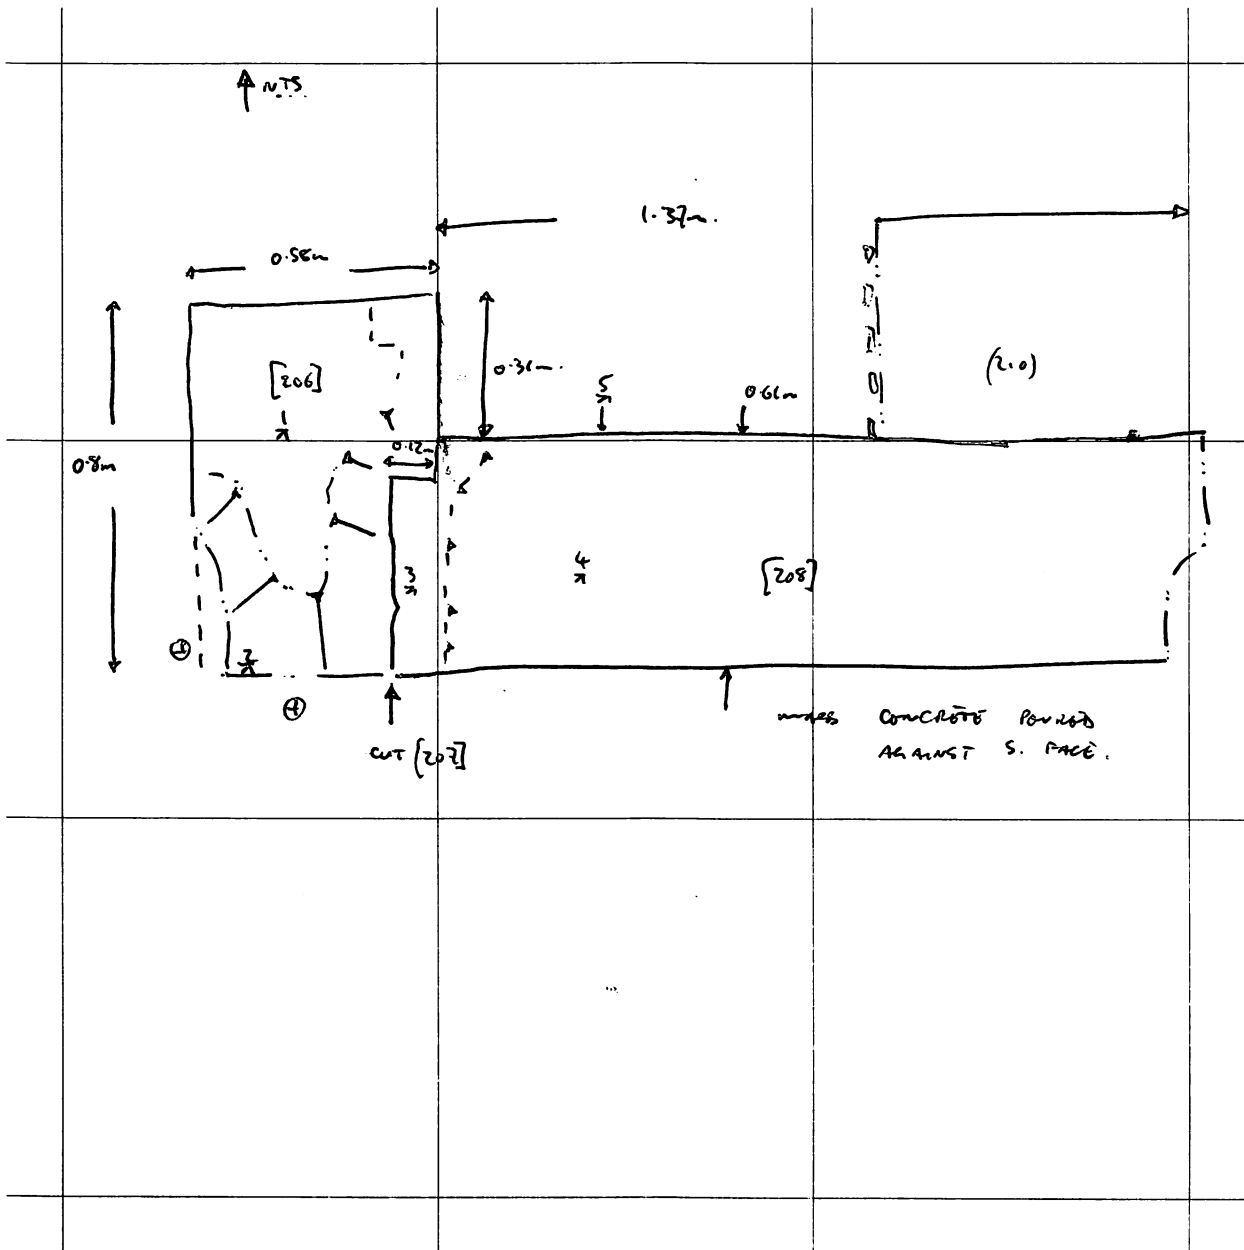
Context Number:  
206

| No. | F/S | R/L (m OD) | No. | F/S | R/L (m OD) | No. | F/S | R/L (m OD) | No. | F/S | R/L (m OD) |
|---|---|---|---|---|---|---|---|---|---|---|---|
| 1 | | 11.69 | | | | | | | | | |
| 2 | | 11.45 | | | | | | | | | |
| 3 | | 11.55 | | | | | | | | | |
| 4 | | 11.55 | | | | | | | | | |
