Site Code: M1612	Grid Square: TP 2	Context Type: MASONRY	Context Number: 72
1. Materials 2. Size of materials (brick: BTL in mm) 3. Finish of stones 4. Coursing / bond 5. Form 6. Direction of face(s) 7. Bonding material (brick: Height of four courses & 4 bed joints in m) 8. Dimensions of masonry as found 9. Other comments	1. UNPROCESSED BRICK		
	2. 200-220mm x 100mm x 60-65mm (MIXED / DIFFERENT BRICKS)		
	3. HANDMADE ORANGE SP BRICK		
	4. IRREGULAR		
	5. DRAIN		
	6. N/A (RNS SW)		
	7. NONE		
	8. 0.40m WIDG, VISIBLE FOR 1.45m		
	9. MIXED MATERIALS USED IN CONSTRUCTION TRUNCATED BY [71]		
POSSIBLY 17th DATE (?)

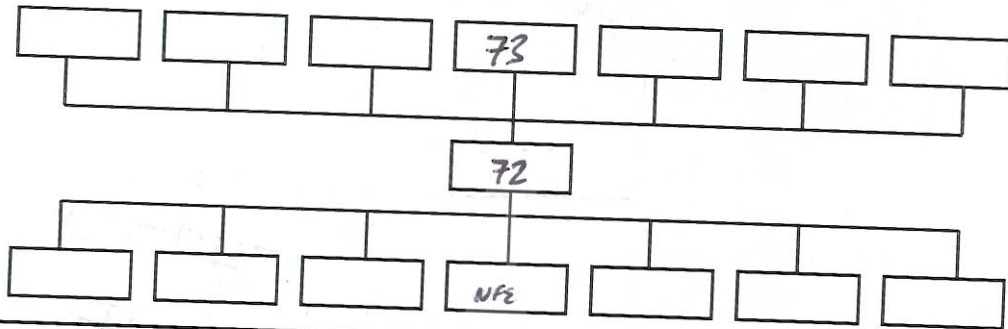
BRICK DRAIN. SIDES OF DRAIN LINED WITH UNBONDED BRICKS, UP TO 4 COURSES HIGH. APPEAR TO BE A NUMBER OF DIFFERENT BRICKS USED - PRESUMABLY THESE ARE BEING REUSED / RECYCLED.

TO WEST DRAIN IS CARRIED BY UNIT OF 4 BRICKS, TO EAST IT IS CARRIED BY SLABS OF VERY SOFT CREAM SILTSTONE.

DRAIN IS CUT BY [71] + THEN REPAIRED. DRAIN CONTINUES TO WEST UNDER [67] + PROBABLY UNDER FLOOR [69].
