Site Code: MN012	Gr. Sq. / TP / Tr: TP. 3	Context Type: Linen	Context Number: 99
Deposit			Cut
1. Compaction	1. None		1. Shape in Plan
2. Colour	2. Slightly reddish brown		2. Corners
3. Composition	3. Sandy silt		3. Dimensions
4. Inclusions	4. Frag dust/shell, frag brick frags		4. Break of slope - Top
5. Dimensions	5. 90 mm to half brick, frag - mod mortar (off green), mod tile frags, occ charcoal flecks, etc. slate		5. Sides
6. Other Comments			6. Break of slope - Base
7. Method/Conditions			7. Base
			8. Orientation
			9. inclination
			10. Truncation
			11. Other comments
	3. 2m x 2m, Thickness 0.01 - 0.14 m		
	6. /		
	7. Mortar + Tiles (1800 Series with unglazed lights)	Min Level: 7.76	
		Max level: 7.91

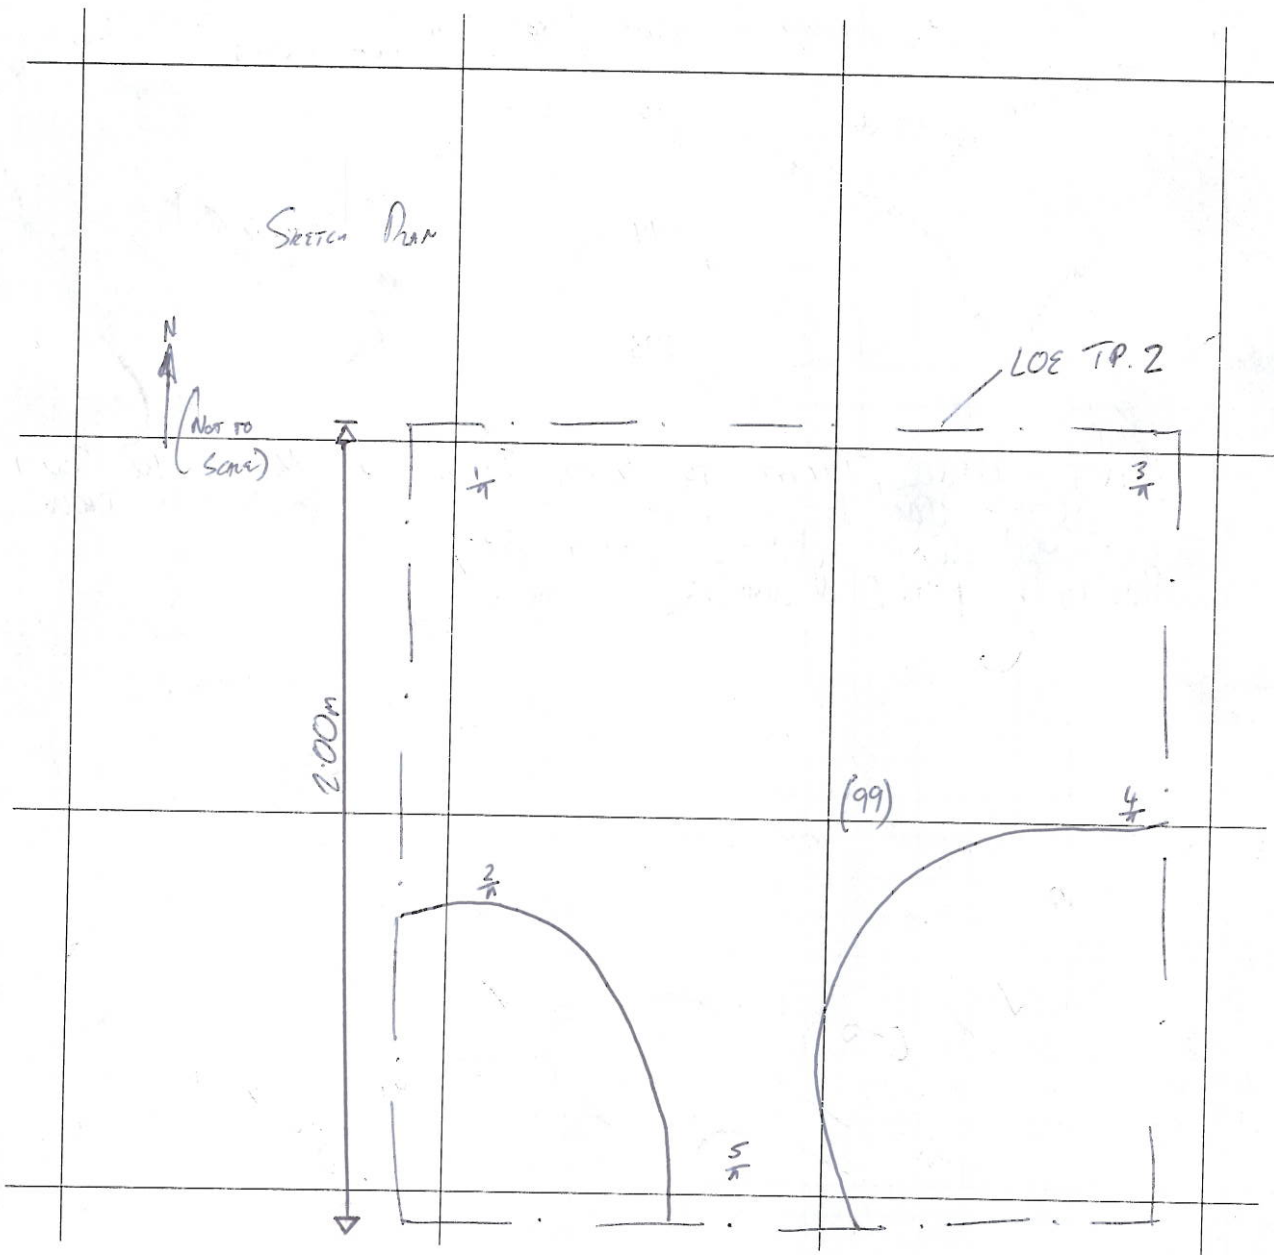
Sketch/levels overleaf:

Uneven thickness Thicker to North, Thins to Nothing to South
Top deposit trampled with pot or top in situ, not surface throw
Foot - med dump, deposit (EMUL (17th))
Patches of crystal shell dumps
