Site Code: MNO12	Location: AREA A	Grid Sq: 145-150/260	Context Type: MASONRY	Context Number: 1054
1. Materials	1. RED FROGGED AND UNFROGGED BRICKS - WHOLE + HALF			
2. Size of materials (brick: BTL in mm)	2. 100 x 65 x 215			
3. Finish of stones	3. /			
4. Coursing / bond	4. NOT ENOUGH LEFT TO TELL - LOOK QUITE RANDOM USE OF RE-USED BRICKS			
5. Form	5. POSSIBLE CESSPIT WALLS.			
6. Direction of face(s)	6. WEST			
7. Surface treatment	7. WORN - RE-USED BRICKS			
8. Bonding material (if brick: record height of 4 courses & 4 bed joints in m)	8. HARD TO TELL - NOT MUCH LEFT - EITHER SAND / CLAY OR REALLY DISINTEGRATED SANDY MORTAR?			
9. Dimensions of masonry as found	9. 1.10m N/S x 140mm E/W x 200mm DEPTH ONLY 2 COURSES			
10. Other comments	10. ASSOCIATED OR SAME AS [1057]?			
				Max Level: 10.19 m OD
				Min Level: 9.99 m OD

Context Number:
1054.

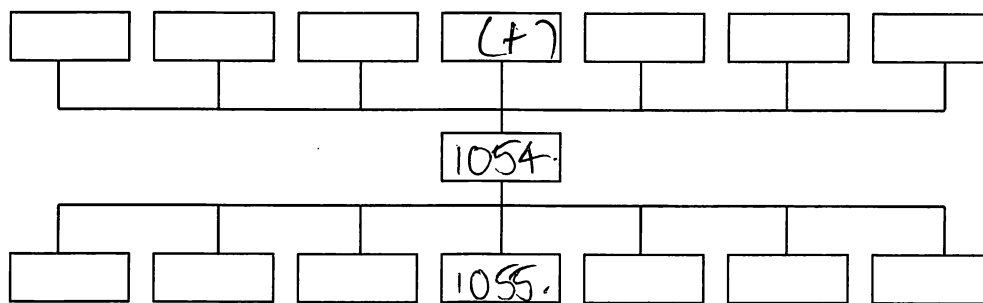
Stratigraphic Relationships:

Abuts: [1057]	Abutted by:
Cut by:

Interpretation:	internal	external
CESSPIT WALL?		
WALL POSSIBLY BUILT UP AGAINST [1057] CREATING CESSPIT. HEAVILY TRUNCATED BY TP 1 AND MODERN CONSTRUCTION. DRAIN (REBUILT) POSSIBLY RAN INTO CESSPIT. [1036]		
Context same as: [1057] ?
