Site Code: MNO12	Gr. Sq. / TP / Tr: A.	Context Type: MASONRY	Context Number: 1021
1. Materials	1. LIGHT RED UNFROGGED BRICKS		
2. Size of materials (brick: BTL in mm)	2. UNKNOWN.		
3. Finish of stones	3. PAINT BRICKS		
4. Coursing / bond	4. SEE SKETCH		
5. Form	5. WALL STUB.		
6. Direction of face(s)	6. NT NW + NE		
7. Bonding material (if brick: record height of 4 courses & 4 bed joints in m)	7. LIGHT SANDY SANDYLIME MORTAR		
8. Dimensions of masonry as found	8. 0.14 - 0.24 ~ x 0.24 ~.		
9. Other comments	9. SOUTH FAN LIMIT NOT OBSERVED

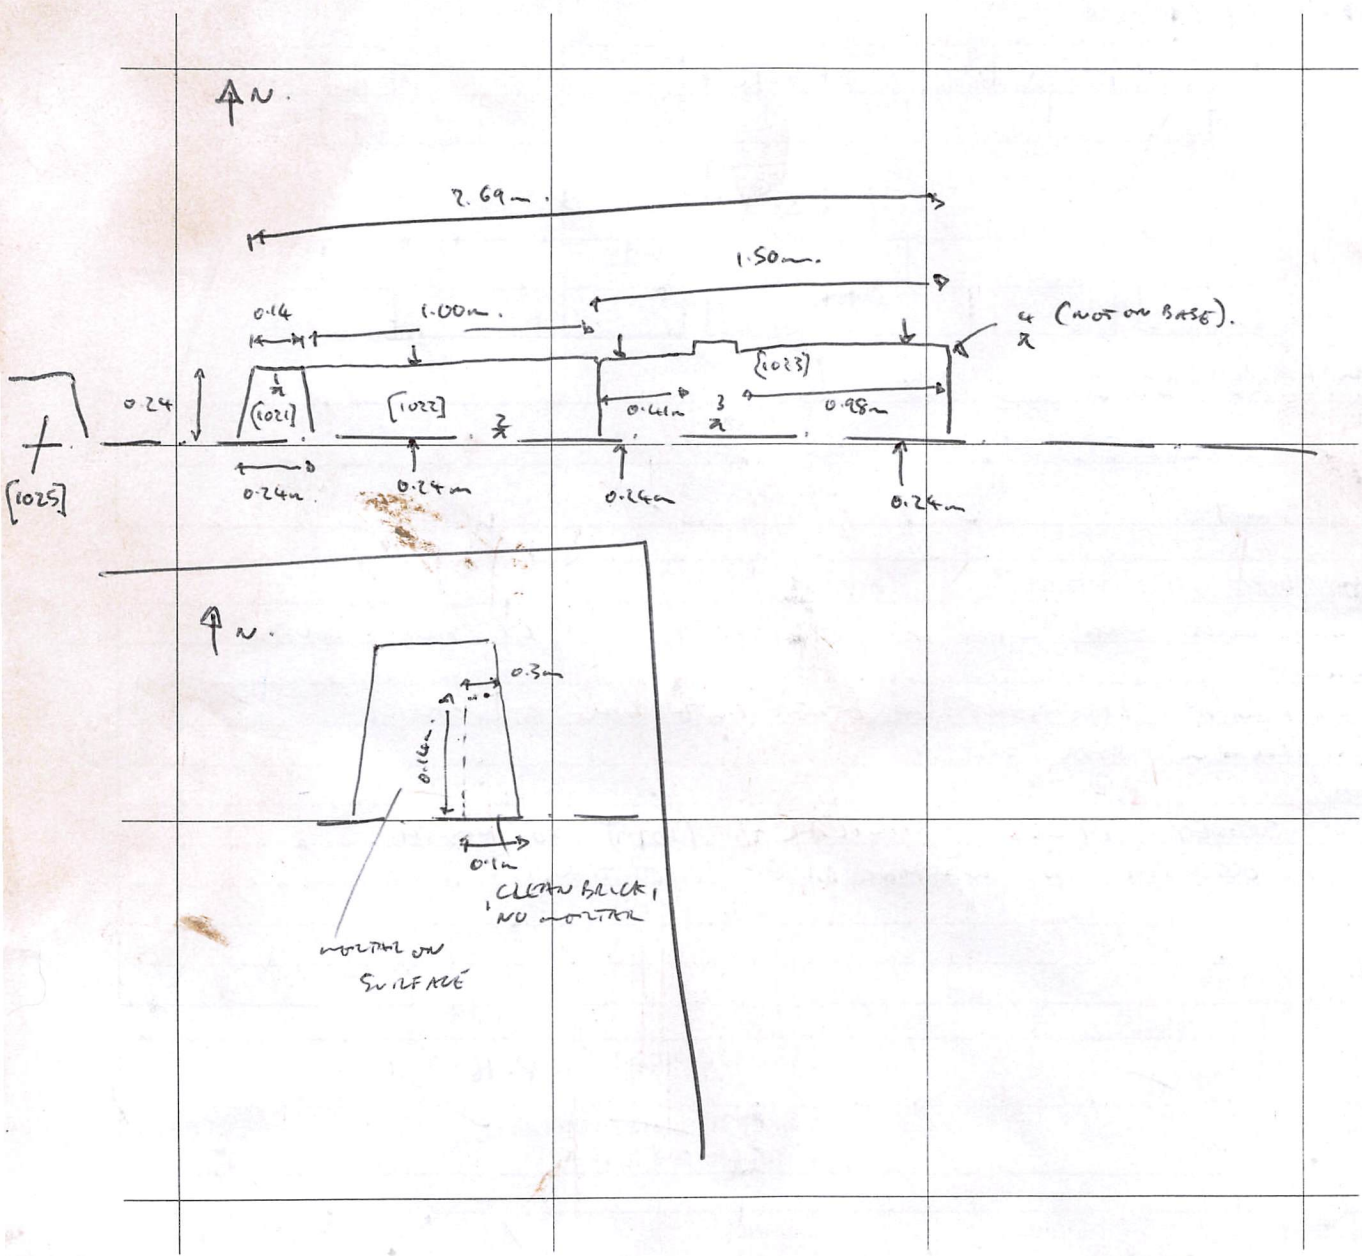
Interpretation:	internal ?	external
BRICK WALL WITH ANGLED SIDES, ONLY ONE COURSE OBSERVED		
PART OF FIRE PLACE? OR OTHER INTERNAL STRUCTURE		
PROBABLY DOOR OPENING		
SIMILAR BY DUMP SIMILAR TO (1029) TO NORTH.		
OBSERVATION IN WATCHING BRICK PILE THROUGH		
Context same as:
