Site Code: MNO12	Location: AREA B	Grid Sq: 120/205	Context Type: MASONRY	Context Number: 2307 2307
1. Materials	1. CERAMIC PIPE - LIGHT YELLOW PIPE			
2. Size of materials (brick: BTL in mm)	2. 140MM DIAMETER			
3. Finish of stones	3. -			
4. Coursing / bond	4. -			
5. Form	5. DRAIN PIPE PASSING THROUGH WALL [2036].			
6. Direction of face(s)	6. -			
7. Surface treatment	7. SMOOTH UNWORN / UNSTAINED			
8. Bonding material (if brick: record height of 4 courses & 4 bed joints in m)	8. PACKED IN GRAVELLY SILT SILT			
9. Dimensions of masonry as found	9. 140 MM DIAMETER 350 MM INTO EXTERNAL SOUTH FACING EDGE OF WALL [2036].			
10. Other comments				
			Max Level:	11.04m OD
			Min Level:	m OD

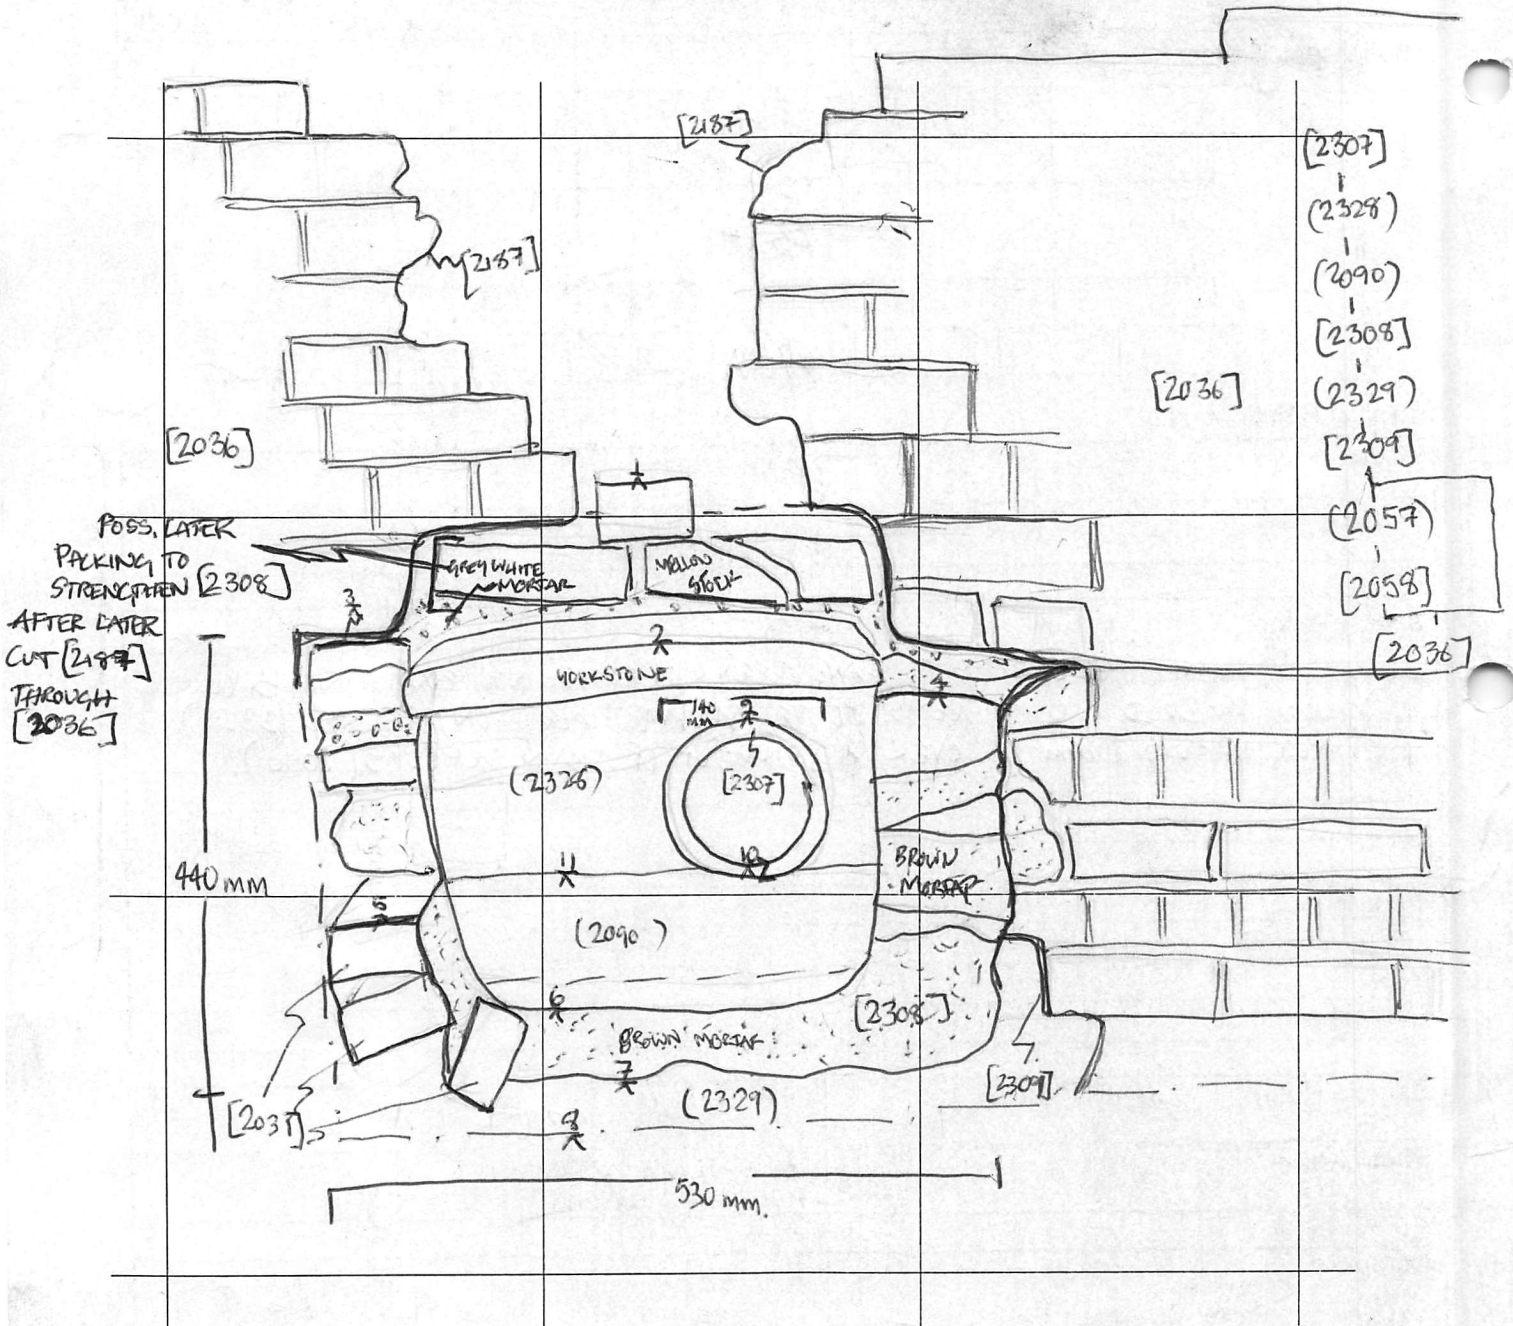
2307

Interpretation:	internal	external
DRAIN PIPE - SEEMS TO HAVE BEEN INSERTED INTO EXISTING BRICK DRAIN RE-BUILD AS IT SEEMS TO BE PACKED PLACED ON BEDDING (2328), WHICH IN TURN IS IS OVER A BUILD-UP OF DRAIN DEPOSITS (2090)		
Context same as:

No.	F/S	R/L (m OD)	No.	F/S	R/L (m OD)	No.	F/S	R/L (m OD)	No.	F/S	R/L (m OD)
1	1.13	11.25	6	1.63	10.75	11	1.56	10.82			
2	1.35	11.03	7	1.75	10.63						
3	1.40	10.98	8	1.77	10.61						
4	1.38	11.05	9	1.34	11.04						
5	1.50	10.88	10	1.48	10.90
