Site Code: MNO12	Location: AREA B	Grid Sq: 120/210 120/205	Context Type: MASONRY	Context Number: 2174
1. Materials	1. YORKSTONE PAVING SLABS			
2. Size of materials (brick: BTL in mm)	2.			
3. Finish of stones	3. SQUARE			
4. Coursing / bond	4. IRREGULAR			
5. Form	5. FLOOR			
6. Direction of face(s)	6. UP			
7. Surface treatment	7. - sandy			
8. Bonding material (if brick: record height of 4 courses & 4 bed joints in m)	8. yellow mortar with inclusions of bricks flcks and small stones (<5mm)			
9. Dimensions of masonry as found	9. 2.70 max (E-W) x 1.66 (N-S)			
10. Other comments				Max Level: 11.16 m OD
				Min Level: 11.13 m OD

Interpretation:	<u>internal</u>	external
REPAIR TO YORKSTONE FLOOR WHERE DRAINAGE HAS BEEN ALTERED.		
SW ROOM NO.1 THE CRESCENT		
Context same as:

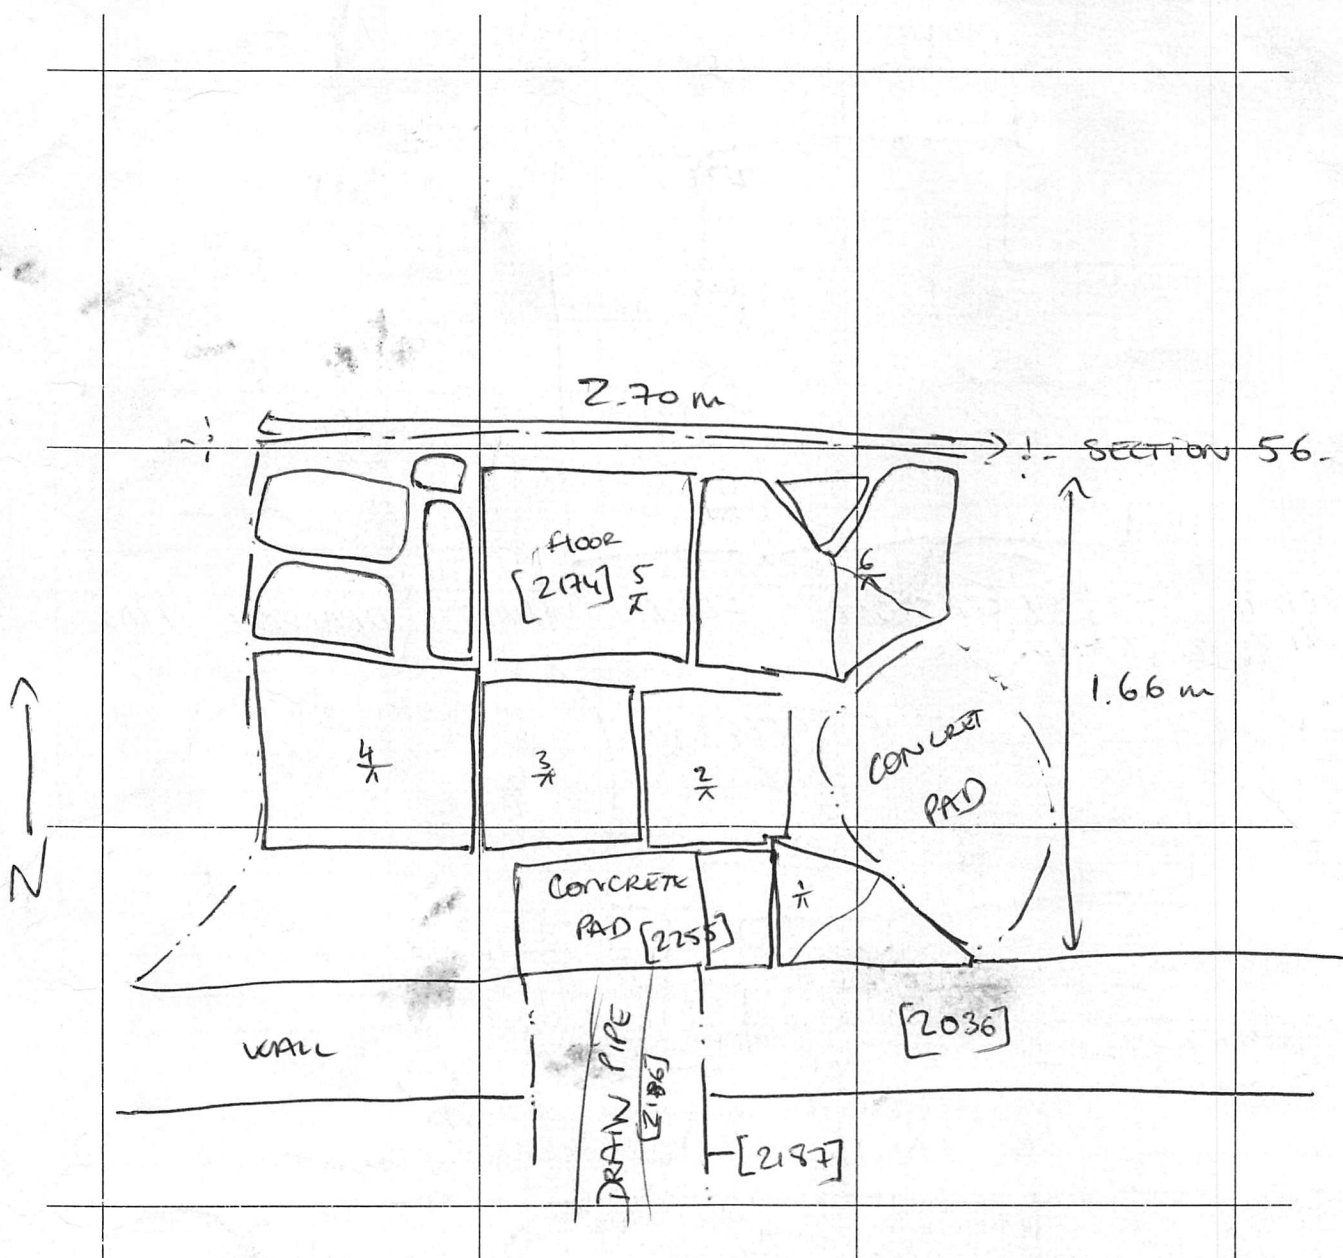
2174

No.	F/S	R/L (m OD)	No.	F/S	R/L (m OD)	No.	F/S	R/L (m OD)	No.	F/S	R/L (m OD)
1	1.27	11.14	2	1.28	11.13						
			3	1.25	11.16						
			4	1.25	11.16						
			5	1.26	11.15						
			6	1.27	11.14
