Site Code: <b>MNO12</b>	Location: <b>B</b>	Grid Sq: <b>115/270</b>	Context Type: <b>MASONRY</b>	Context Number: <b>2167</b>
1. Materials	① <b>RED BRICK</b>			
2. Size of materials (brick: BTL in mm)	② <b>220 mm x 110 mm x 60 mm</b>			
3. Finish of stones	③ <b>SLIGHTLY WORN.</b>			
4. Coursing / bond	④ <b>ONLY 2 COURSES BUT PROBABLY ENGLISH BOND</b>			
5. Form	⑤ <b>WALL</b>			
6. Direction of face(s)	⑥ <b>N/S</b>			
7. Surface treatment	⑦ <b>N/A</b>			
8. Bonding material (if brick: record height of 4 courses & 4 bed joints in m)	⑧ <b>HARD GREY MORTAR</b>			
9. Dimensions of masonry as found	⑨			
10. Other comments				Max Level: <b>11.09</b> m OD
				Min Level: <b>10.95</b> m OD

Interpretation:	<u>internal</u>	external
<b>THRESHOLD IN DOORWAY OF REAR CENTRAL ROOM IN NO. 2 THE CRESCENT. ABUTS THE TWO ROOM WALLS [2046] AND [2047] AND IS</b>		
Context same as:

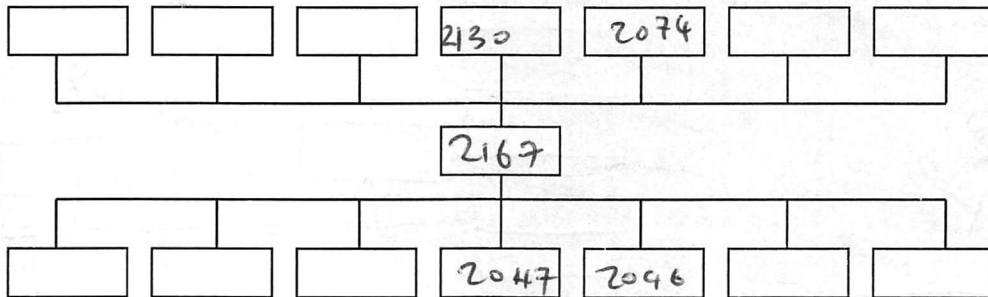
Stratigraphic Relationships:

Physical Relationships:

Abuts: <b>2047, 2046</b>	Abutted by: <del>2130</del> <b>2130</b>
Cut by: <b>—</b>

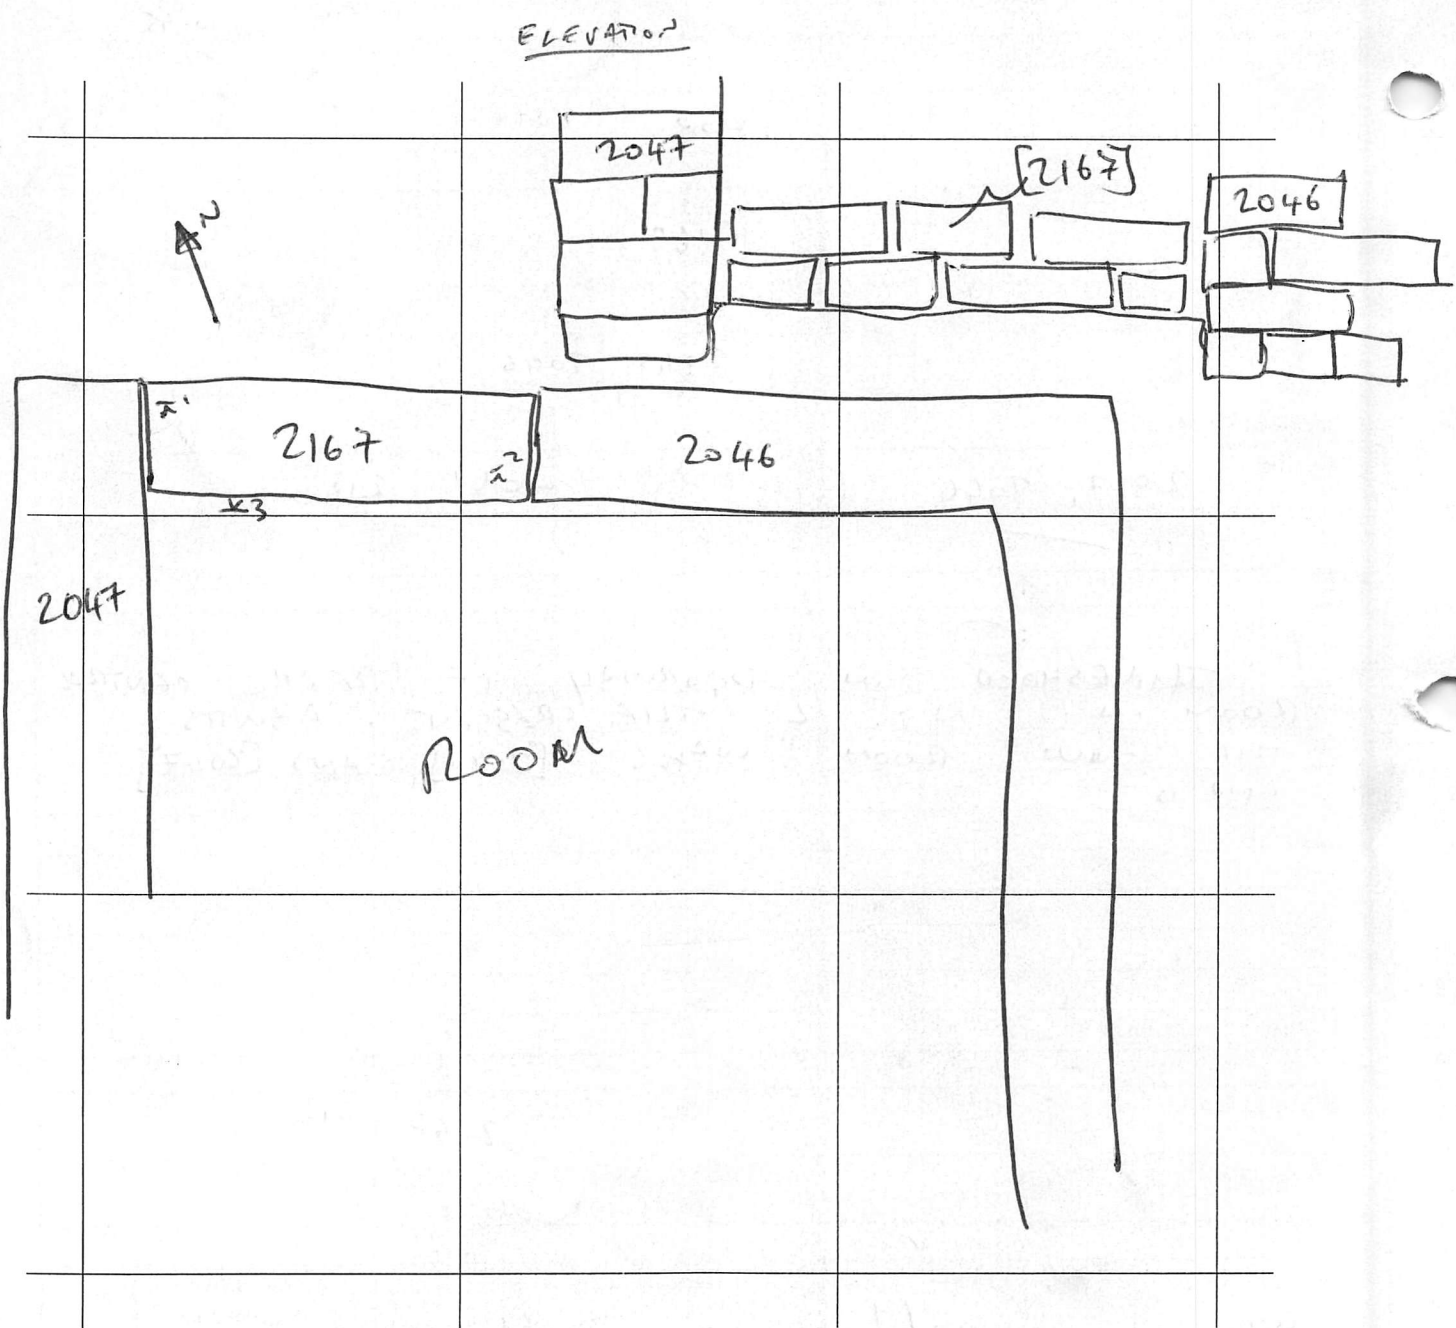
Context Number:  
2167

No.	F/S	R/L (m OD)	No.	F/S	R/L (m OD)	No.	F/S	R/L (m OD)	No.	F/S	R/L (m OD)
1	1.32	11.09									
2	1.37	11.04									
3	1.46	10.95
