Site Code: MNO12	Location: B	Grid Sq: 125-130/200	Context Type: MASONRY	Context Number: 2381 1043
1. Materials	1. Soft hand made bricks			
2. Size of materials (brick: BTL in mm)	2. 190 190 x 69 x 230 mm			
3. Finish of stones	3. English bond			
4. Coursing / bond	4. Bonds wall			
5. Form	5. East facing South face			
6. Direction of face(s)	6. N/A			
7. Surface treatment	7. 16 courses: 1.22 m <small>SPAT MID GRAY LIME MORTAR, OCCAS</small>			
8. Bonding material (if brick: record height of 4 courses & 4 bed joints in m)	8. 1.22 mod 16 courses; dark yellowish grey limestone inclusions <small>ANNOUAT</small>			
9. Dimensions of masonry as found	9. N/S - 2.06 mod F.W. 5.90 mod <small>LIME FLINTS</small>			
10. Other comments	Depth: 1.22 mod 0.24 ~ 0.105			
				Max Level: 10.43 10.43 m OD
				Min Level: 9.58 m OD

Context Number:
2666 2381

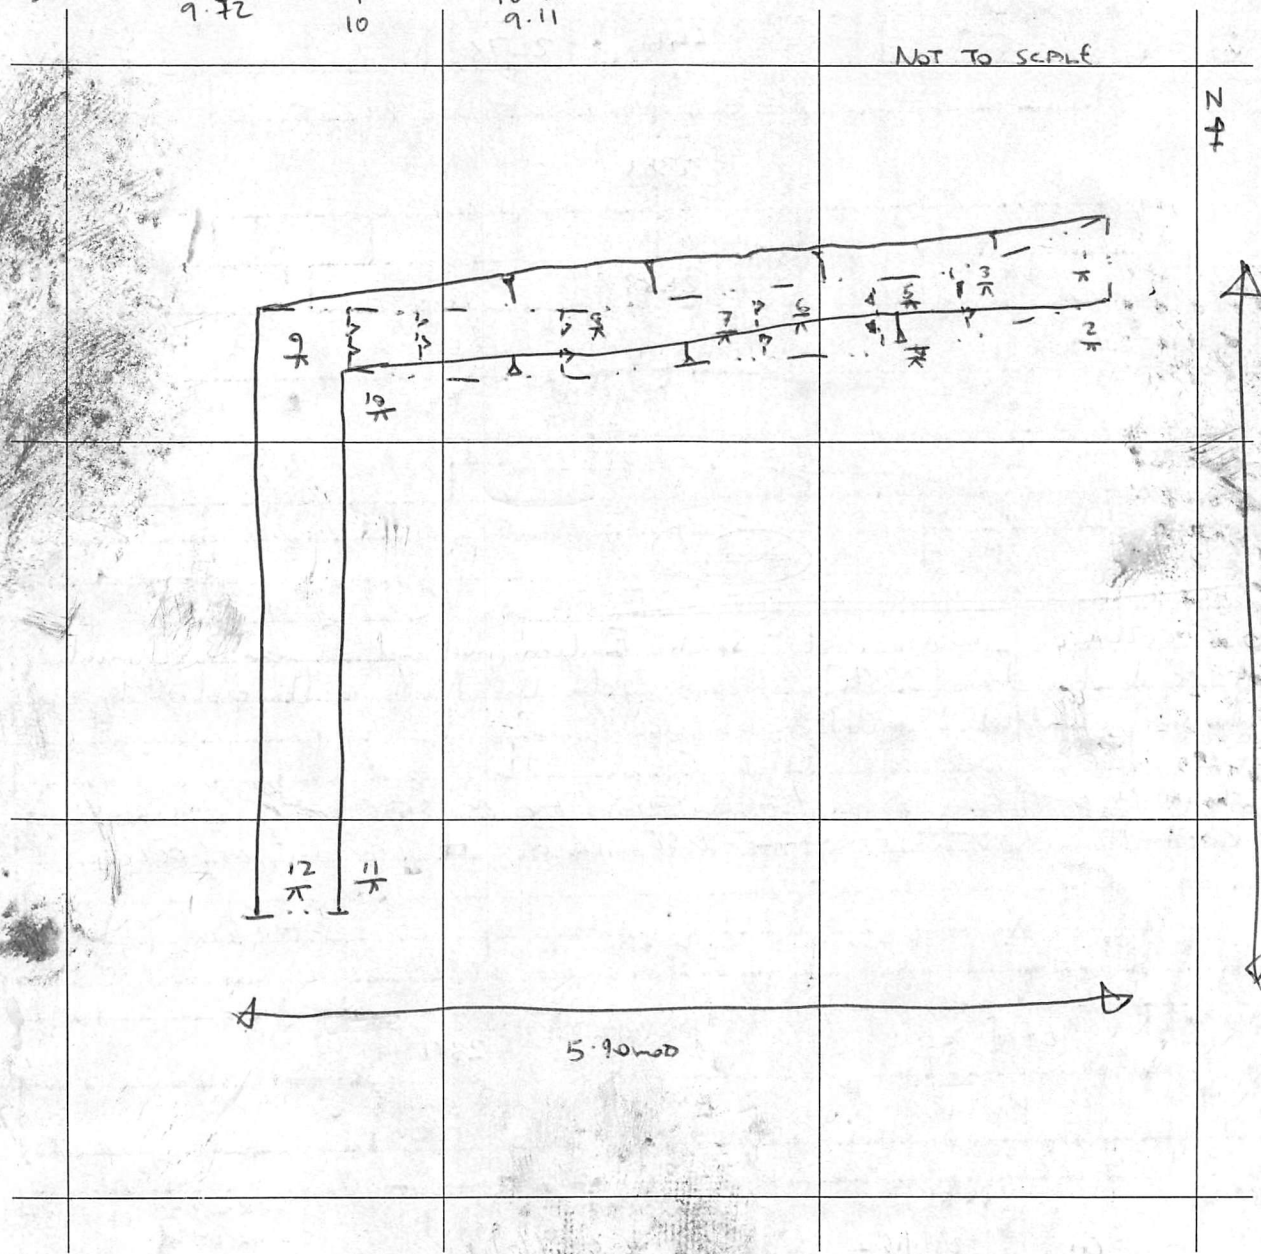
Interpretation:	internal	<u>external</u>
BACK FILL OF VINE STAKE CONCRETE		
CONCRETE WALL at South Eastern end of area B; Exposed to the East by drain [2386]; disjunct to the North in the centre by rubble cut [2484]		
WALL WAS COLLAPSING / DEMOLISHED ON N. SIDE BUT BRICKS CLEANED OUT FOR RE-USE PRIOR TO INFILL OF COURSE		
Context same as:

1 9.58
 2 9.33
 3 9.83
 4 9.25
 5 9.72
 6 9.73
 7 9.95
 8 10.01
 9 10.10
 10 9.11
 11 9.05
 12 10.43

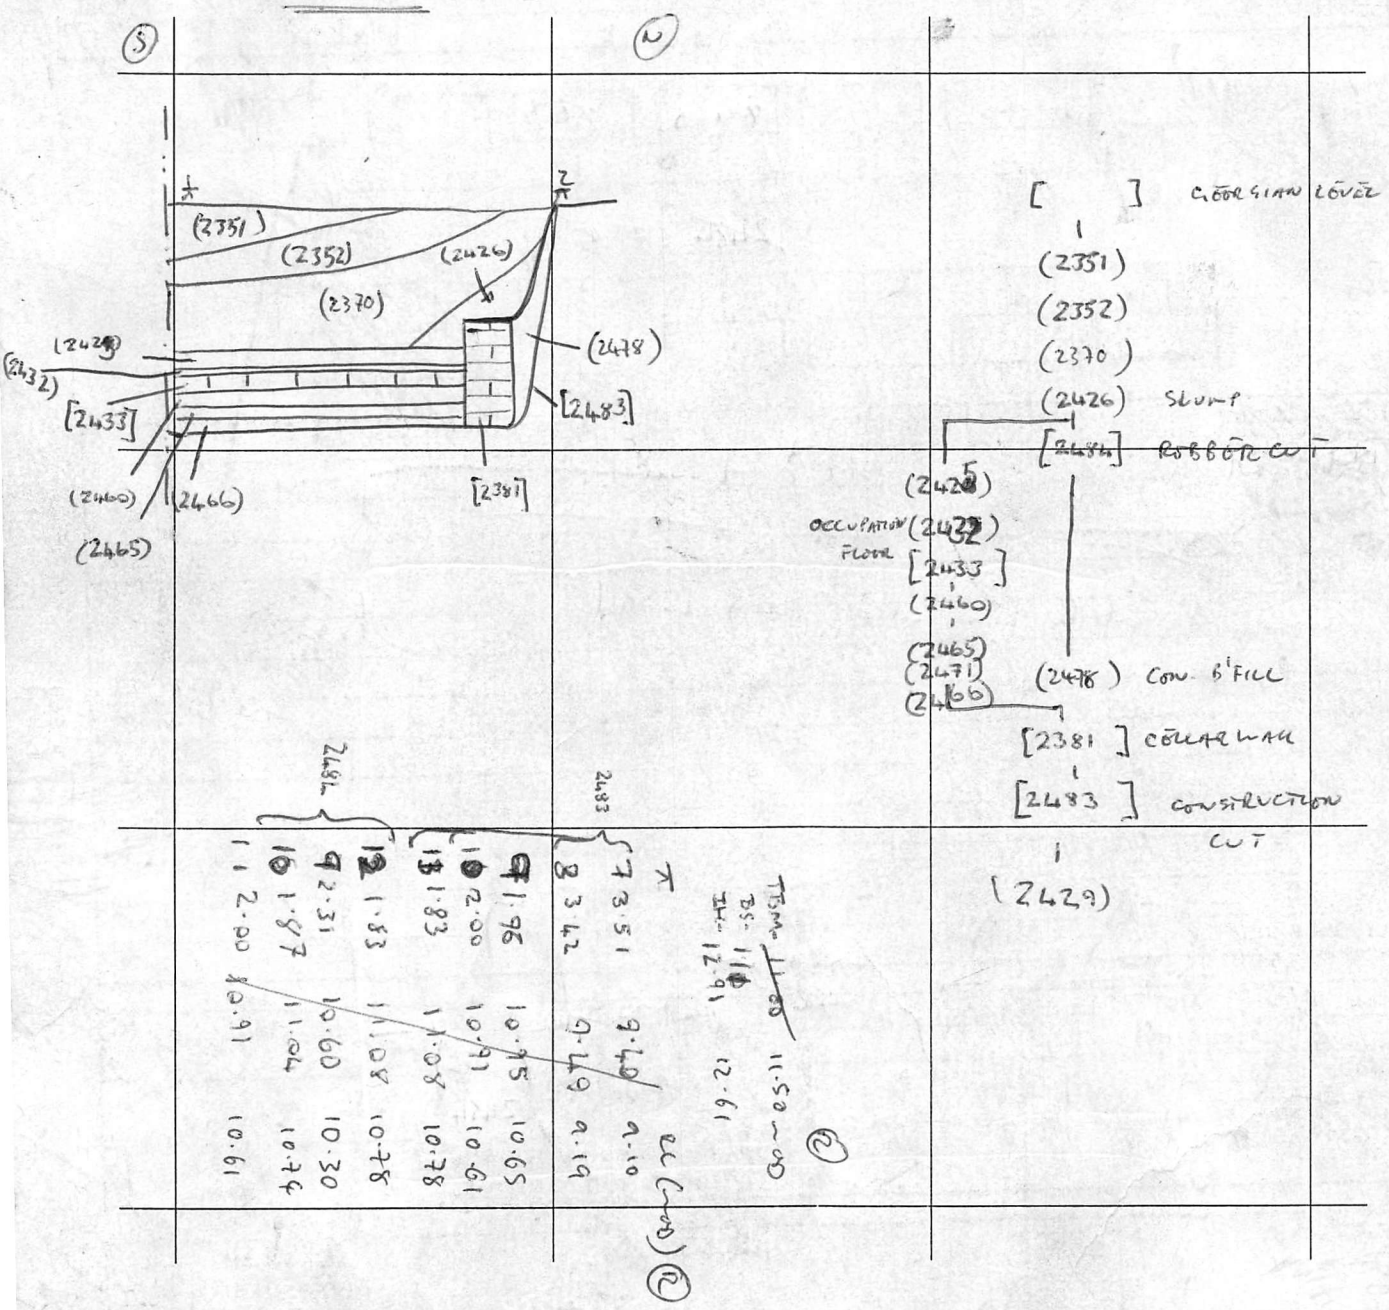
EAST FACING SECTION
COLLAR [2381]

Interpretation:	Internal	External	Structural
Robb. cut	<i>see over for sketch + matrix</i>		
Context same as:
