Site Code: MNO12	Location: <i>AREA B</i>	Grid Sq: <i>120/215</i>	Context Type: MASONRY	Context Number: <i>2323</i>
1. Materials	<i>1. RED BRICK, SLIGHT FROG, HARD; CEMENT</i>

Interpretation:	<input checked="" type="checkbox"/> internal	<input type="checkbox"/> external
<i>SLEEPER WALL IN FRONT ROOM OF NO. 1 THE</i>		
<i>CHES. WAS UNDERNEATH HEARTHSTONE IN FIRE PLACE</i>		
Context same as:

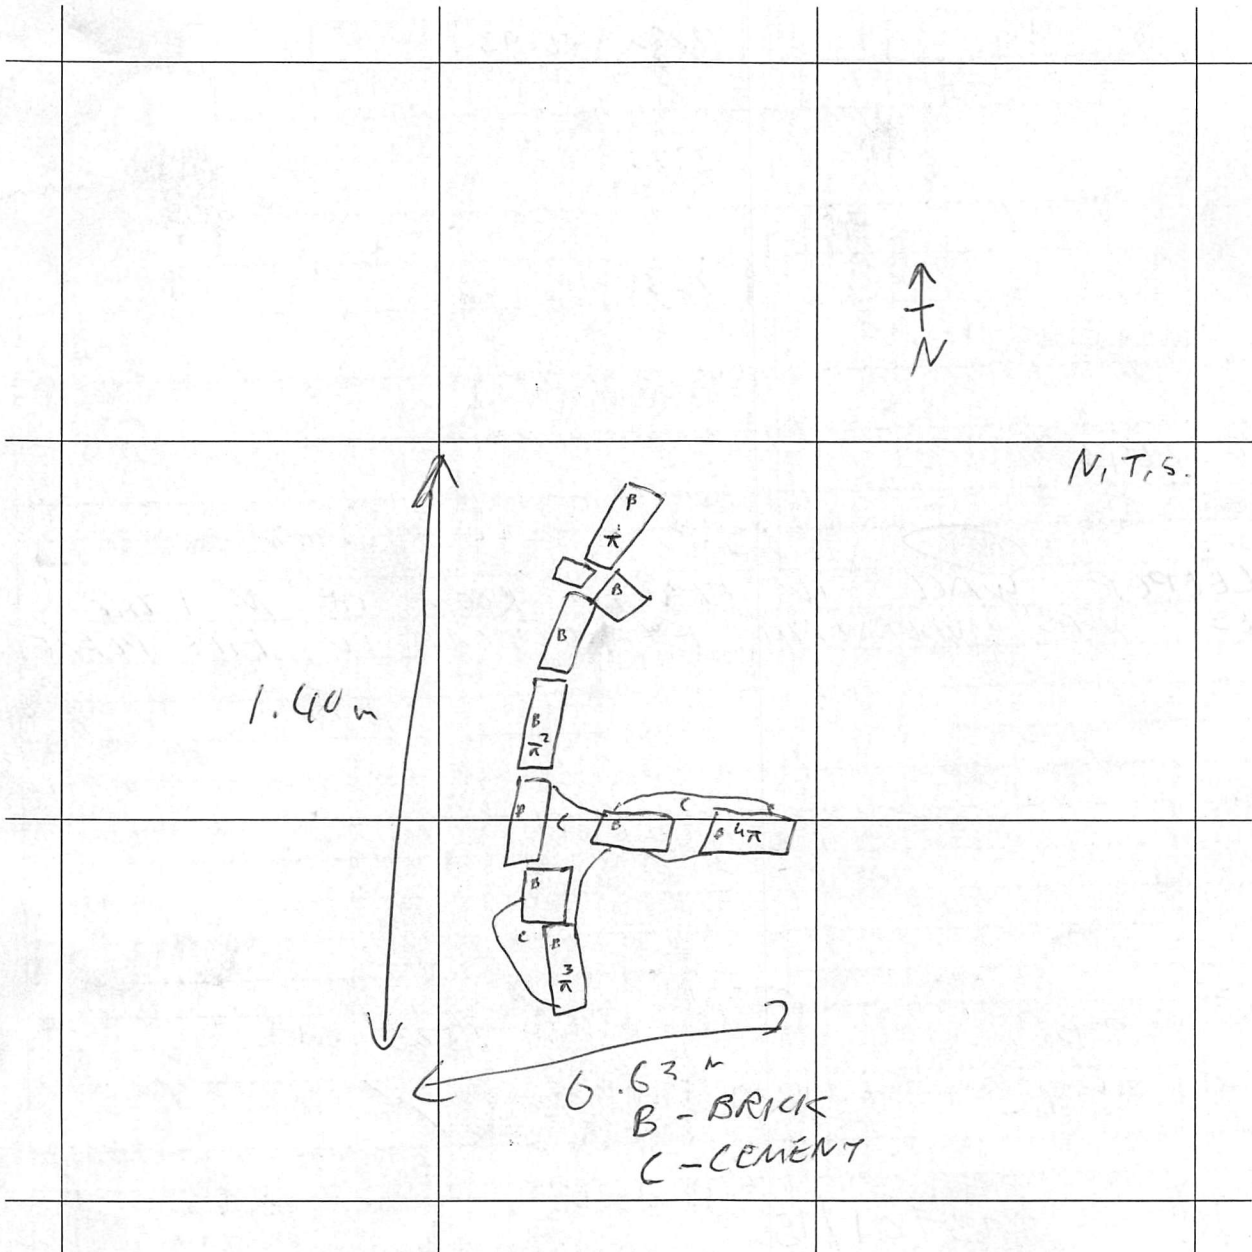
Context Number:
2323

No.	F/S	R/L (m OD)	No.	F/S	R/L (m OD)	No.	F/S	R/L (m OD)	No.	F/S	R/L (m OD)
1	1.35	11.0.3									
2	1.34	11.04									
3	1.34	11.04									
4	1.30	11.08
