Site Code: <b>MNO12</b>	Location: <b>B</b>	Grid Sq: <b>120/205</b>	Context Type: <b>MASONRY</b>	Context Number: <b>2106</b>
1. Materials	1) <b>YELLOW PLASTER WITH WHITE LIME WASH</b>			
2. Size of materials (brick: BTL in mm)	2) <b>0.59M HEIGHT; 1.15M ACROSS (E-W); &lt;5mm THICK</b>			
3. Finish of stones				
4. Coursing / bond	6) <b>NORTH FACE OF WALL [2036] ON WEST SIDE OF WALL [2042]</b>			
5. Form				
6. Direction of face(s)				
7. Surface treatment				
8. Bonding material (if brick: record height of 4 courses & 4 bed joints in m)				
9. Dimensions of masonry as found				
10. Other comments				Max Level: <b>12.01</b> m OD
				Min Level: <b>11.48</b> m OD

Panel ID:  
2106

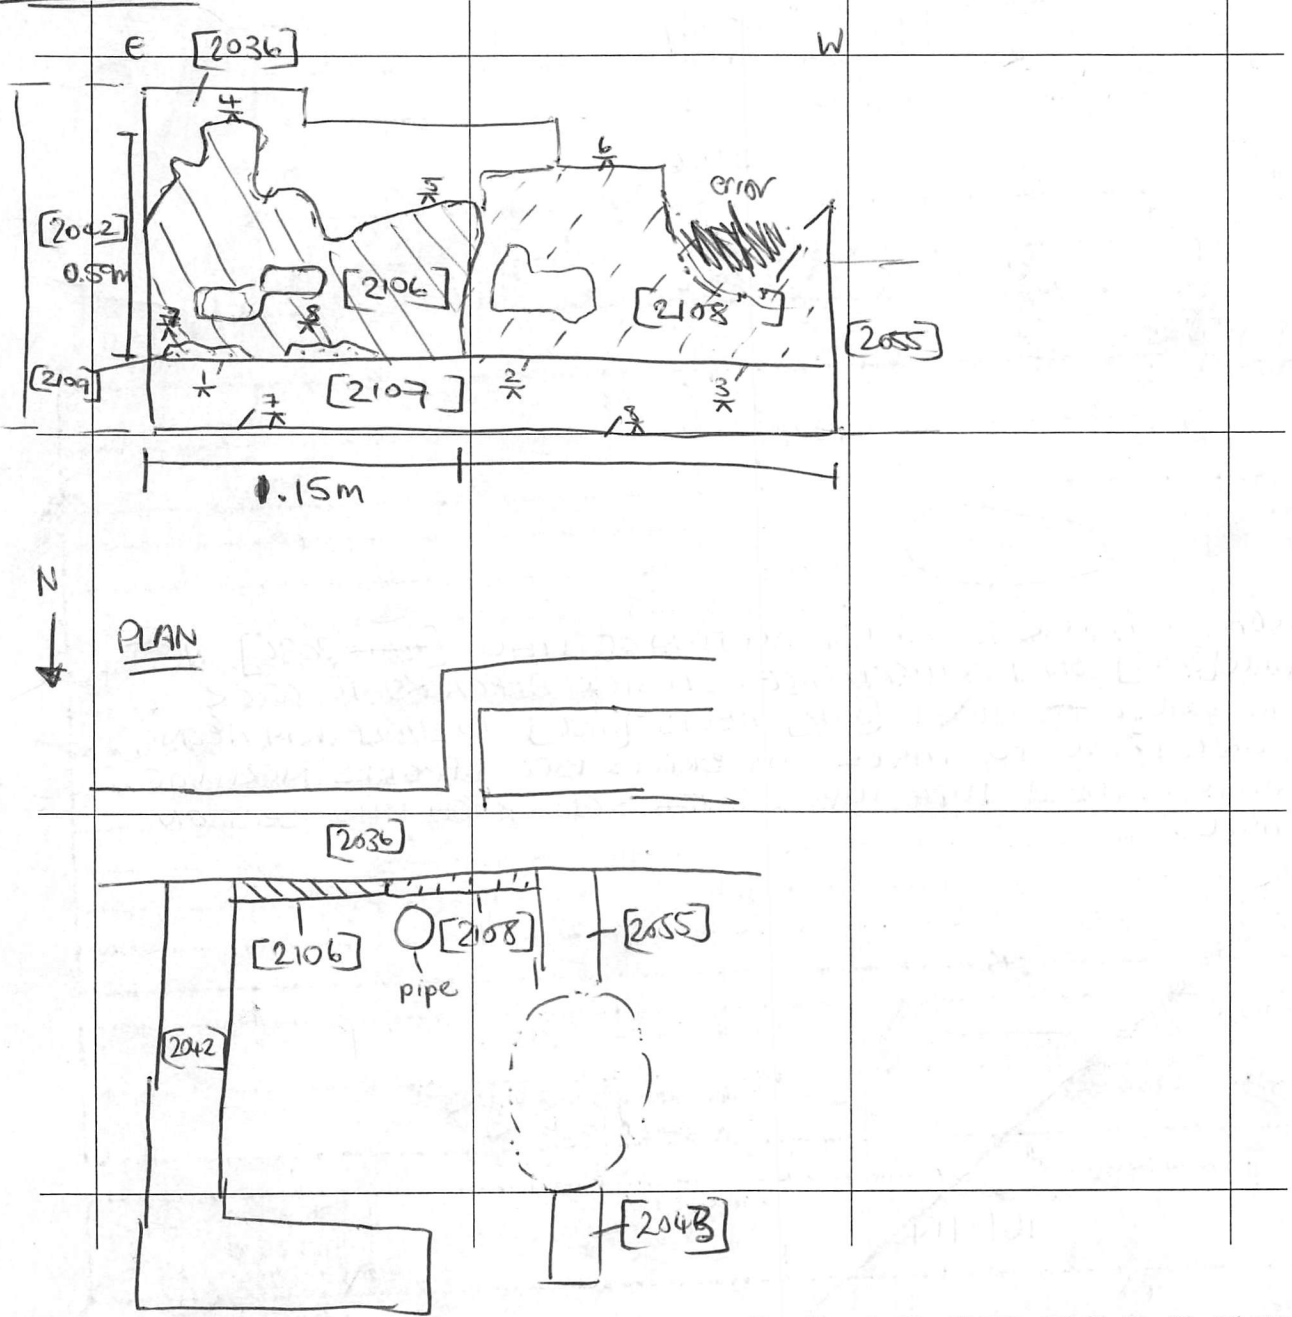
NORTH FACE

Interpretation:	<input checked="" type="radio"/> internal	<input type="radio"/> external
<p><b>YELLOW PLASTER COVERING SECTION OF WALL [<del>2036</del> 2036], WEST OF WALL [2042] ON NORTHERN FACE. PLASTER APPEARS TO COVER FROM CORNER OF WHERE [2042] ABUTS [2036] TO HALF WAY ALONG THE WALL CLOSE TO WHERE THE DRAIN PIPE APPEARS NORTH OF THE WALL. ONE OF THREE TYPES OF <del>RENDER</del> RENDER ON THIS SECTION OF WALL.</b></p>		
Context same as:
