Site Code: <b>MNO12</b>	Location: <b>B</b>	Grid Sq: <b>125/205</b>	Context Type: <b>MASONRY</b>	Context Number: <b>2110</b>
1. Materials	1. LIGHT GREY PLASTER WITH CHALK/LIME AND BLACK INCLUSIONS. THIS IS COVERED WITH LIME WASH.			
2. Size of materials (brick: BTL in mm)	2. 0.20M HEIGHT; 0.14M ACROSS (N-S); 15MM THICK			
3. Finish of stones				
4. Coursing / bond	6. ON WEST FACE OF WALL [2042]			
5. Form				
6. Direction of face(s)				
7. Surface treatment				
8. Bonding material (if brick: record height of 4 courses & 4 bed joints in m)				
9. Dimensions of masonry as found				
10. Other comments				
				Max Level: 11.76 m OD
				Min Level: 11.53 m OD

Context Number:  
2110

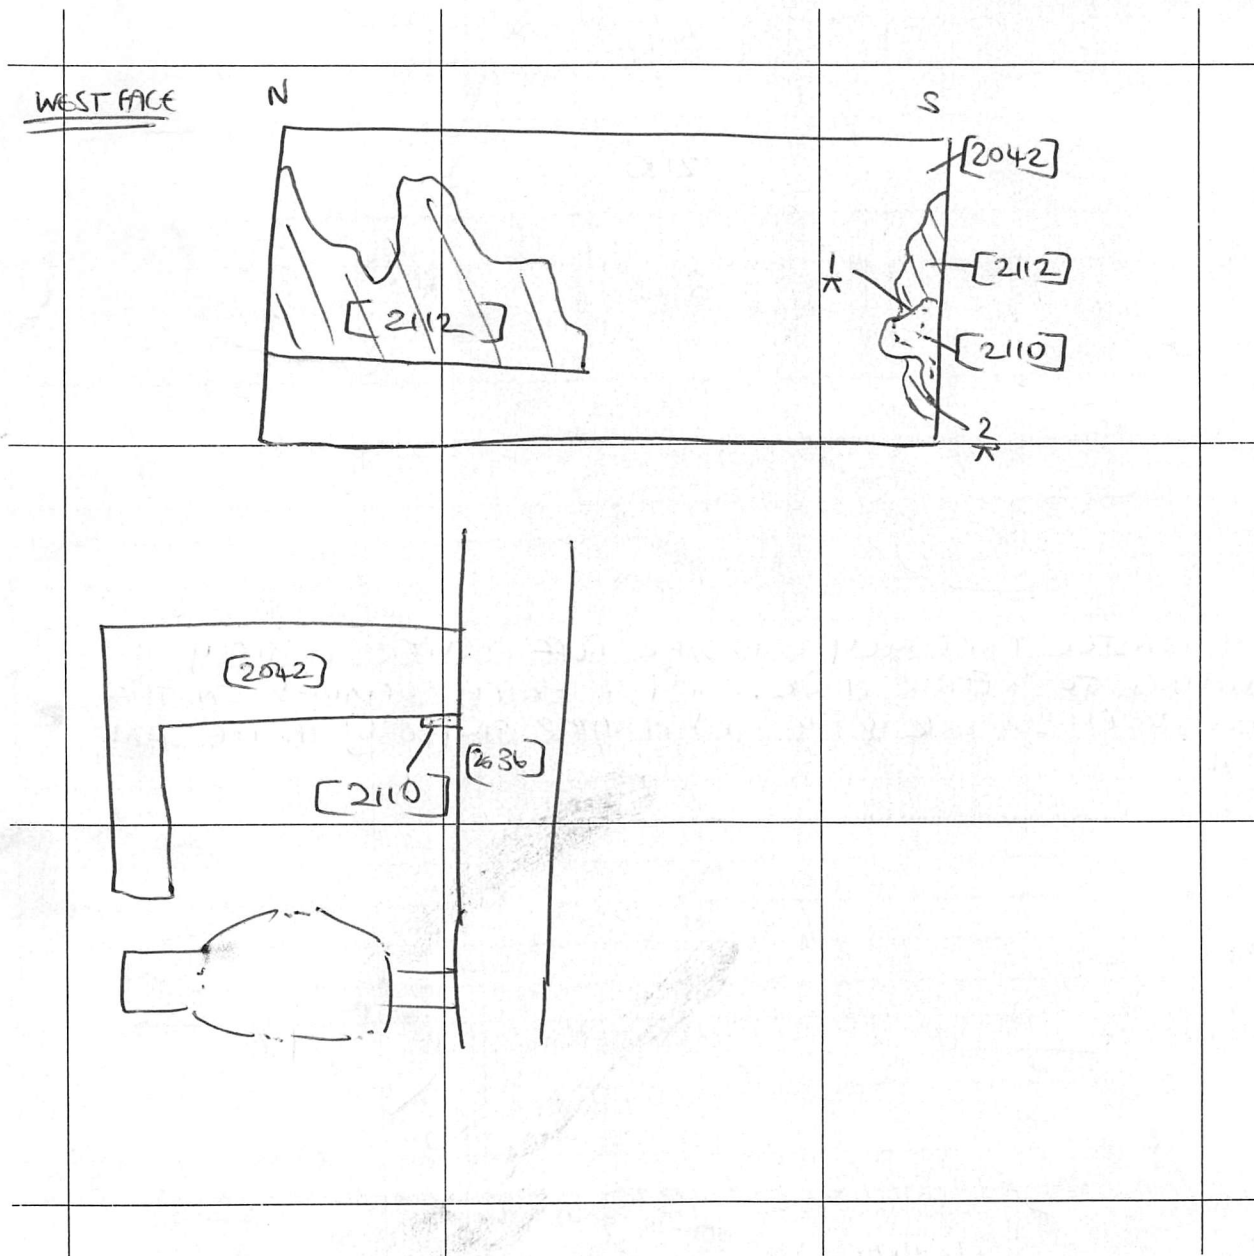
Interpretation:	<input checked="" type="checkbox"/> internal	<input type="checkbox"/> external
GREY PLASTER PARTIALLY LAID OVER BUFF PLASTER, POSSIBLY RELATING TO REPAIR WORK. ONLY A PATCH SURVIVES ON THE WALL. VERY SIMILAR TO THE GREY PLASTER ON [2036] IN THE SAME ROOM.		
Context same as: <del>A</del>

No.	F/S	R/L (m OD)	No.	F/S	R/L (m OD)	No.	F/S	R/L (m OD)	No.	F/S	R/L (m OD)
1	0.50	11.76									
2	0.73	11.53
