Site Code: MNO12	Location: B	Grid Sq: 120/210	Context Type: D&P	Context Number: 2457
Deposit	① FIRM COMPACT ② M.G - PARTLY CRACKED BROWN ③ SANDY SILT ④ MODERATE CRM (RED BRICK, TILE) 20-50mm MODERATE GRAVEL (ROUNDED) OCCASIONAL MORTAR 50mm OCCASIONAL COBBLE 100-200mm Text MODERATE SHEL			 Cut 1. Shape in Plan 2. Corners 3. Dimensions 4. Break of slope - Top 5. Sides 6. Break of slope - Base 7. Base 8. Orientation 9. Inclination 10. Truncation 11. Other comments
1. Compaction				
2. Colour				
3. Composition				
4. Inclusions				
5. Interface				
6. Dimensions				
7. Other Comments				
8. Method/Conditions				
				Max Level: 10.44 m OD
				Min Level: 10.02 m OD

Interpretation:	Internal	External	Structural
DUMP - MADE UP LAYER IN YARDS. COMPRESSED BY PARTY WALL OF 18th BUILDING.			
Context same as:

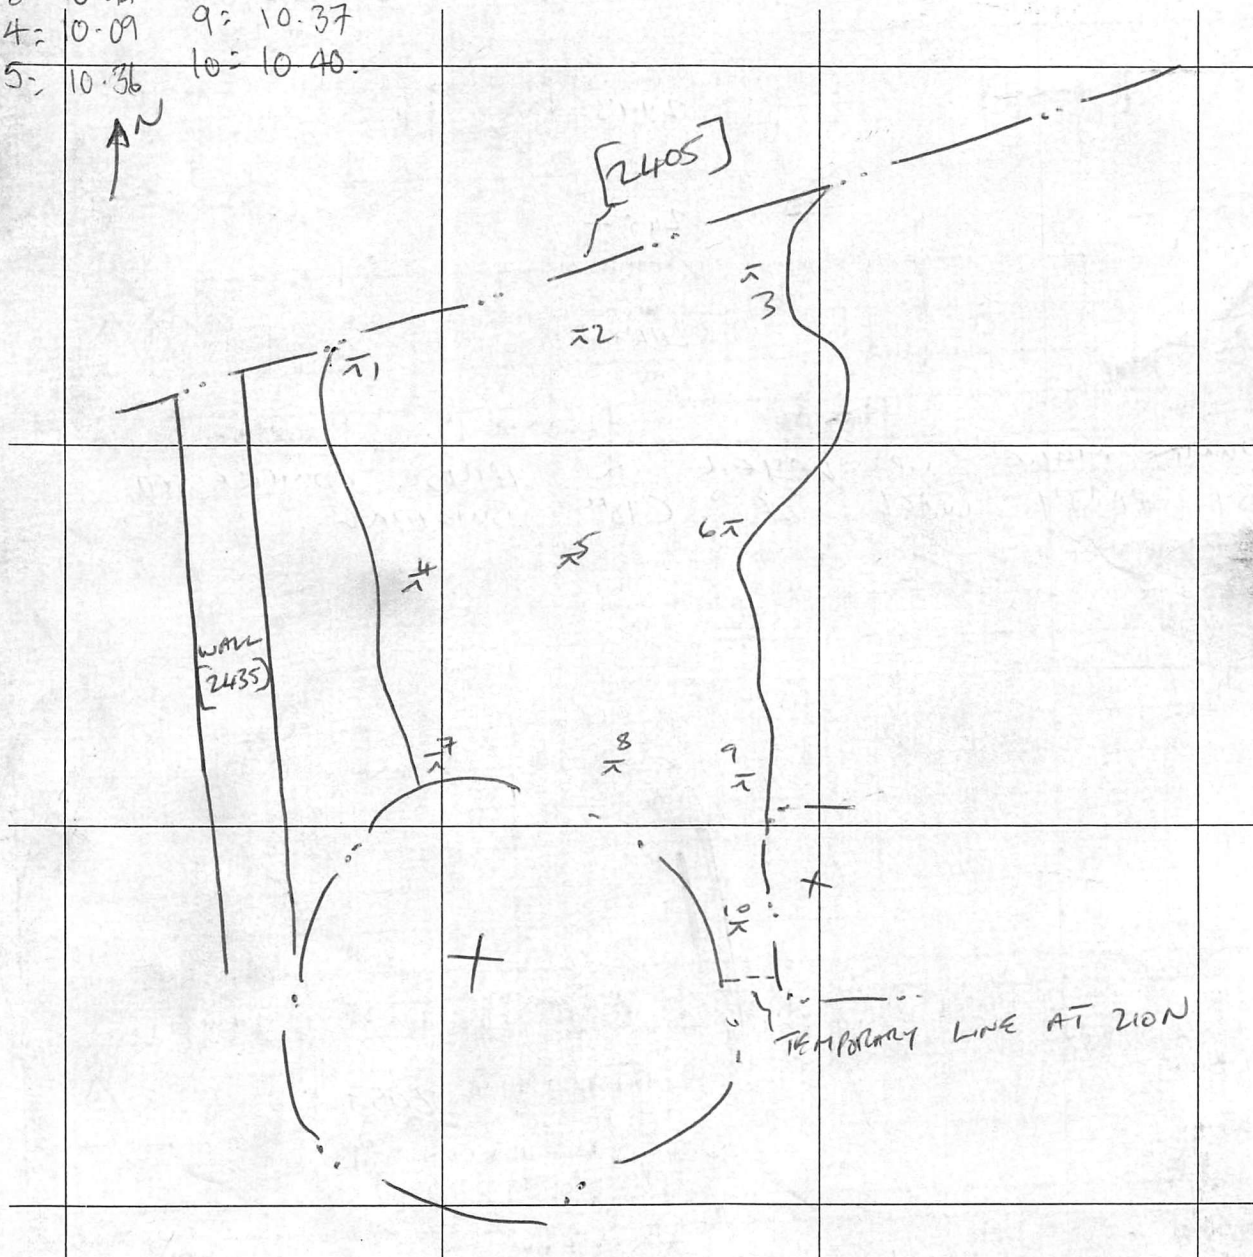
Level No.s
 TBM 11.50 11.50
 B/S 1.11 1.11
 IH 12.61 12.91

No.	F/S	R/L (m OD)	No.	F/S	R/L (m OD)	No.	F/S	R/L (m OD)	No.	F/S	R/L (m OD)
1	2.52	10.39	6	2.17	10.74						
2	2.33	10.58	7	2.59	10.32						
3	2.17	10.74	8	2.45	10.46						
4	2.52	10.39	9	2.24	10.67						
5	2.25	10.66	10	2.21	10.70

1 = 10.09 6 = 10.44
 2 = 10.28 7 = 10.02
 3 = 10.44 8 = 10.16
 4 = 10.09 9 = 10.37
 5 = 10.36 10 = 10.40
