Site Code: MNO12	Grid Square: 115/210/120/210	Context Type: TIMBER	Context Number: 2686
1 Type	① JOISTS x 4		
2 Setting	② WITHIN RECTANGULAR PIT. HORIZONTAL		
3 Orientation	APPROX. 0.8M - 1M BETWEEN EACH JOIST		
4 Cross-Section	③ N-S		
5 Condition	④ VARIOUS - SEE INDIVIDUAL SHEETS		
6 Dimensions m/mm	⑤ DAMAGED. INCOMPLETE. IN SITU.		
7 Conversion	⑥		
8 Tool Marks	⑦		
9 Joints & Fittings			
10 Intentional Marks			
11 Surface Treatment	⑧		
12 Other Comments			
13 Method & Conditions	⑨		
⑩ CONTAINS TIMBERS 7, 8, 9 AND 18.			
Reuse	Yes:	No:	Unknown:
Phases of Reuse: POSSIBLE BUT UNCLEAR ON SITE.

Interpretation:
 GROUP OF 4 TIMBER JOISTS T7, 8, 9 + 18
 WITH RECTANGULAR PIT. LATEST TIMBER ADDITION
 TO PIT [2691]. POSSIBLY FOR PLANKED FLOOR
 WITHIN N PART OF PIT. ROBBED OUT AFTER
 USE - SOME PINE PLANKS (T1, 2, 6) FOUND IN
 (2681) AREA.

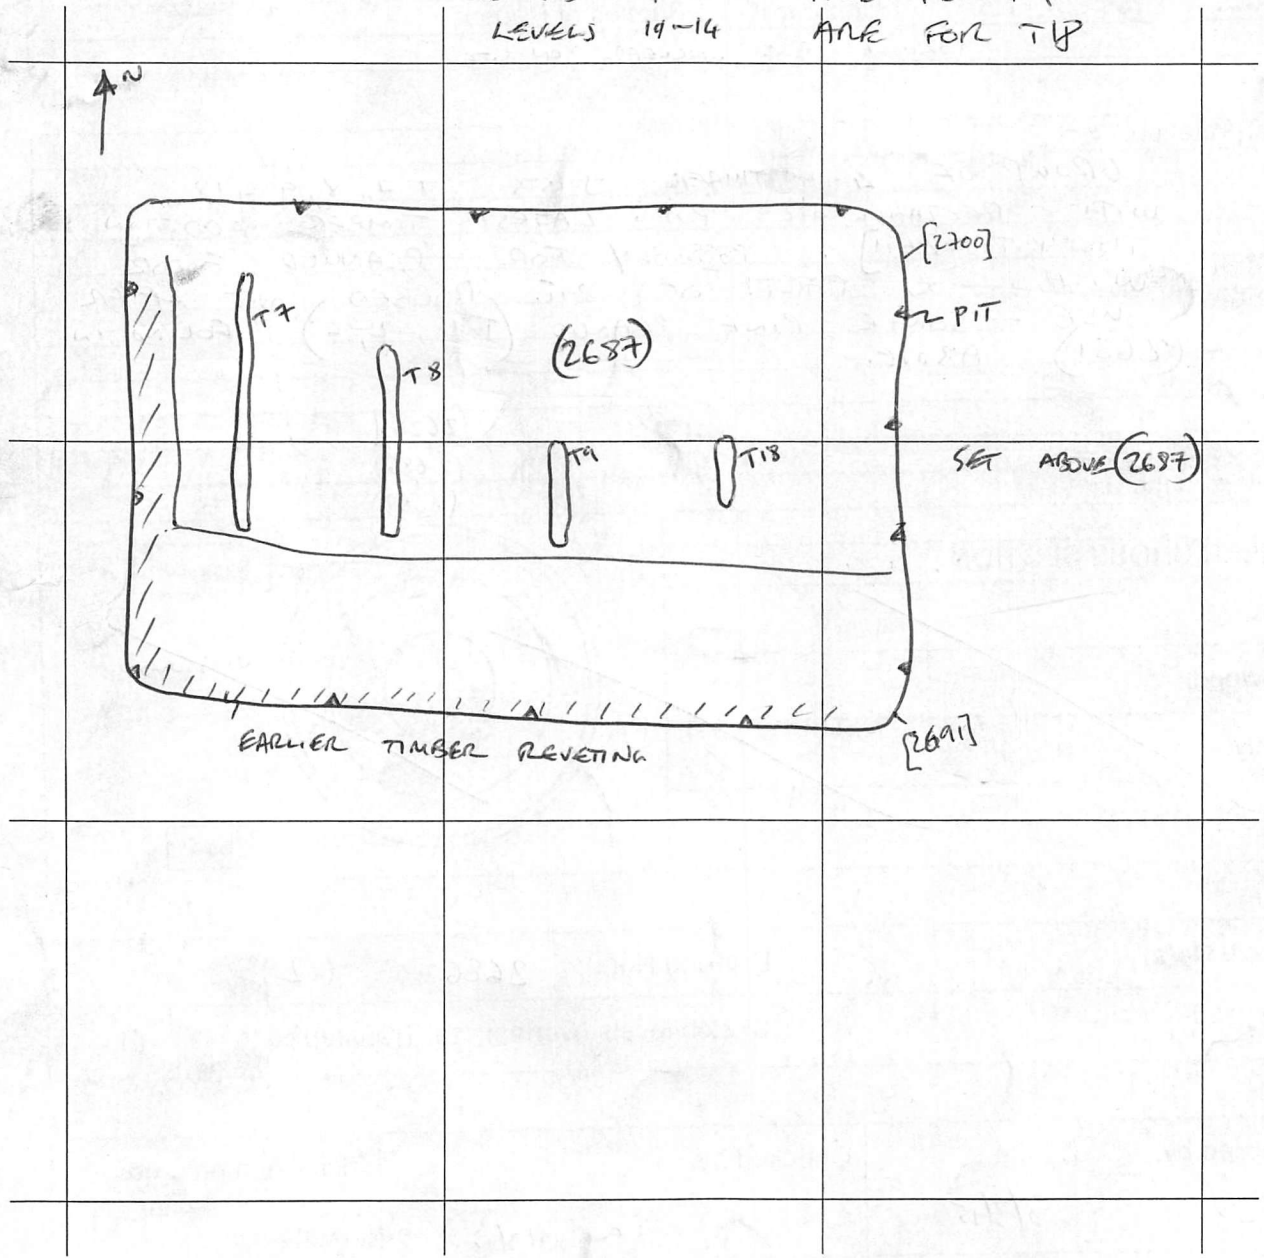
No.	F/S	R/L (m OD)	No.	F/S	R/L (m OD)	No.	F/S	R/L (m OD)	No.	F/S	R/L (m OD)
1		8.19	6	3.16	8.11	11	2.91	8.36			
2		8.17	7	2.97	8.30	12	2.89	8.38			
3	3.02	8.25	8	2.93	8.34	13	2.98	8.29			
4	3.04	8.23	9	3.03	8.24	14	2.93	8.34			
5	3.15	8.12	10	3.01	8.26

LEVELS 1-2 ARE FOR T7
LEVELS 3-6 ARE FOR T8
LEVELS 7-10 ARE FOR T9
LEVELS 11-14 ARE FOR T10
